A Reliability Study of Phased Array Ultrasonic Inspections Applied to Aluminothermic Welds in Rails

Abstract. Nowadays, long welded railway rails are achieved by means of aluminothermic and flush-butt welding processes. Compared to bolted joints, welds proved to be effective in terms of reduced wheel damage, ride comfort and maintenance. However, even if the event is inexplicably not considered in relevant standards, surface cracks often initiate within the welded and the heat affected regions of the foot, leading to brittle failure. On the subject, a recent work developed a probabilistic methodology for determining day-by-day failure probability. However, apart from this structural integrity study and few others, a complete damage tolerance approach should also consider the capability of nondestructive inspections. The latter is recognized as an essential input to define maintenance inspection intervals. The present work is focused on the capability assessment of Phased Array ultrasonic inspection applied to aluminothermic-welded joints by means of Probability of Detection curves, as a result of experimental and Model Assisted data samples.

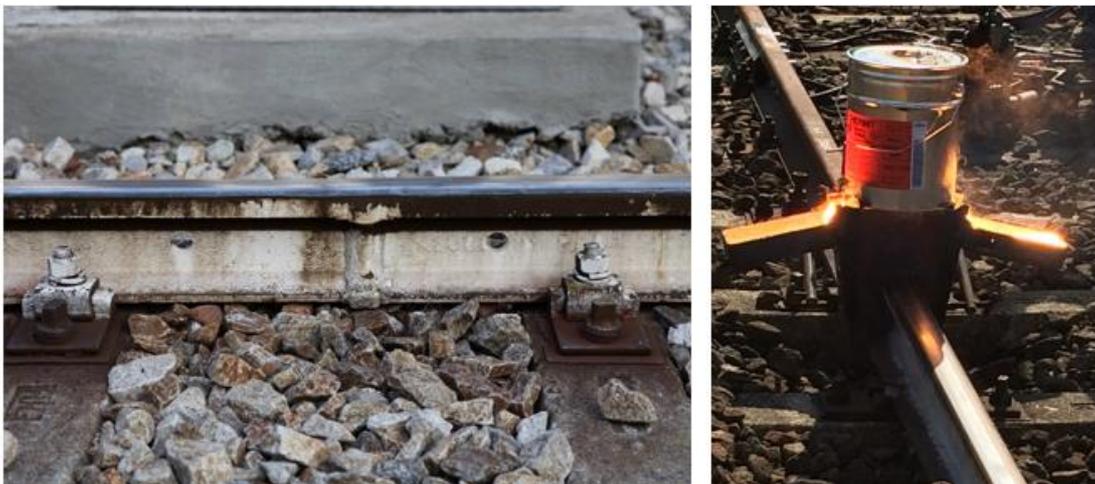
Fig. 1. The “long welded rail”.

The so called “long welded rail” (Fig. 1) is gradually substituting traditional bolted joints because it proves to be more effective in terms of reduced wheel damage, ride comfort and maintenance. Two manufacturing processes can be applied for manufacturing the welds: aluminothermic and flush-butt. The present research considers the former [1], which is manufactured by an on-site foundry process (Fig. 1).

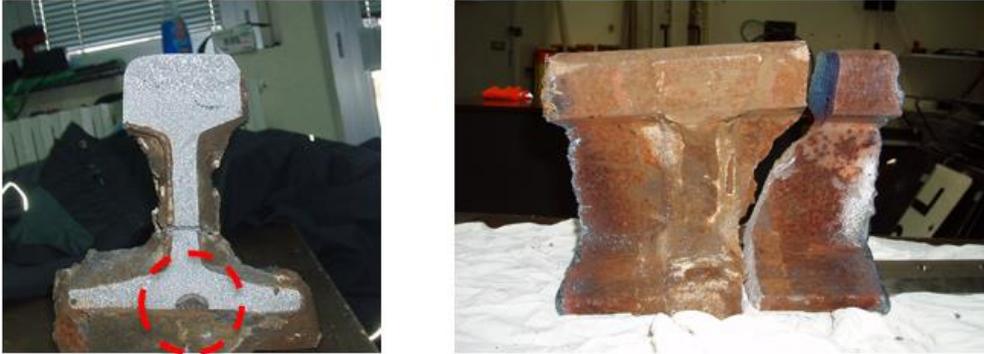
Fig. 2. Typical in-service failure of the long welded rail.

Aluminothermic welded rails can fail during service, most often, by surface cracks initiating, due to defects and/or stress concentrations, within the welded and the heat affected regions of the foot and causing brittle failure after short propagation (Fig. 2). Inexplicably, this event is not fully considered in relevant standards, such as [2], even if periodic maintenance NDT inspections are prescribed by conventional ultrasonic testing and only considering centred cracks inspected from the rolling surface. This means the lateral tips of the foot are never inspected during service.

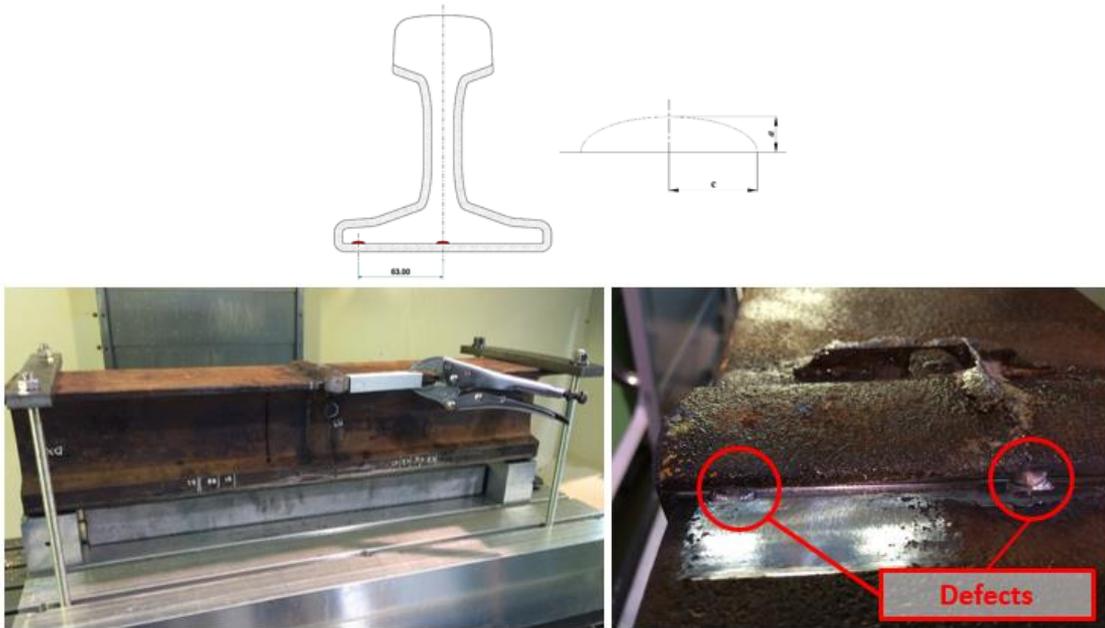
Fig. 3. Manufacturing of artificial notches in welded rails.

Artificial semi-elliptical notches were introduced (Fig. 3) into two samples of welded rails, taken from service, at the location of the maximum stress concentration. The considered material is a R260 steel grade and the profile type is 60E1, both according to [2]. Two sets of notches, one at the symmetrical axis of the section and the other at the foot lateral tip, were manufactured by milling, using a spherical tip tool, and were all characterized by an aspect ratio equal to 0.4. Notches depth varied from 0.5 mm to 2 mm, with a few intermediate values, by a progressive increase by machining between inspections.

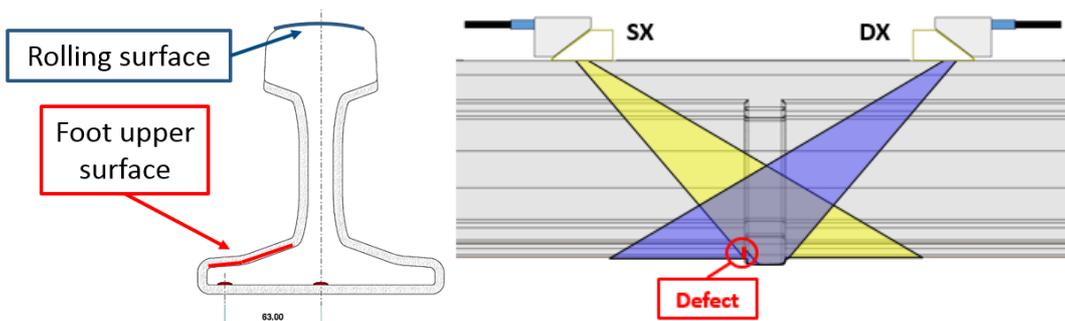
Fig. 4. Approaches to inspections.

An Olympus Omniscan phased array unit was used to carry out all inspections. In particular, central notches were inspected (Fig. 4) from the rolling surface by a 2L64-A2 linear probe (2.25 MHz, 64 elements, S-Scan: 40°- 60°), while lateral ones from the foot upper surface by a 2L8-DGS1 linear probe (2.25 MHz, 8 elements, S-Scan: 50°- 70°). Moreover, each notch was inspected from both its side with respect to the weld (approach here named “SX”) and the other side (approach here named “DX”). The latter implies the full interaction of the sound beam with the weld and the heat affected zones.

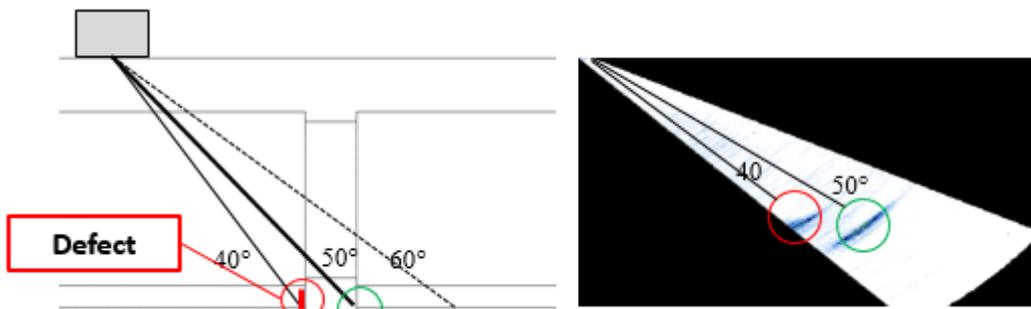
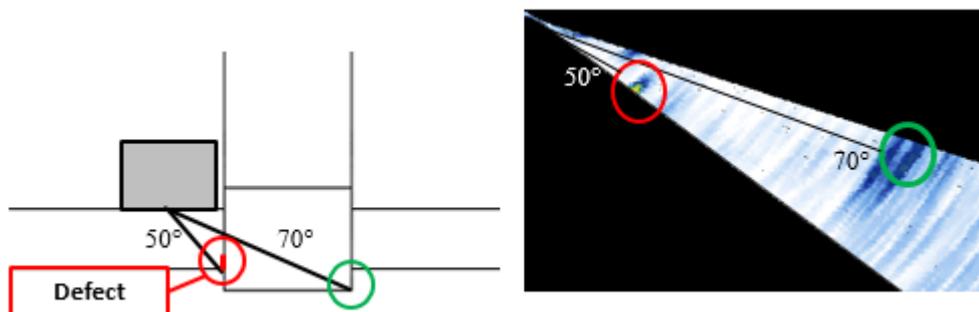
Fig. 5. Examples of S-Scans from welded rails: a) from rolling surface; b) from foot upper surface.

Figure 5 shows some examples of S-Scans obtained, during inspections, adopting the SX approach. As can be seen, both the inherent geometry and the artificial notch can be clearly detected by the chosen operative parameters. In particular, the reported S-Scan ranges are those optimized for the application after several trials based on the best the trade-off between the needs of the inspections and accessibility due to the geometry of the welded rail, especially considering the lateral tips of the foot.

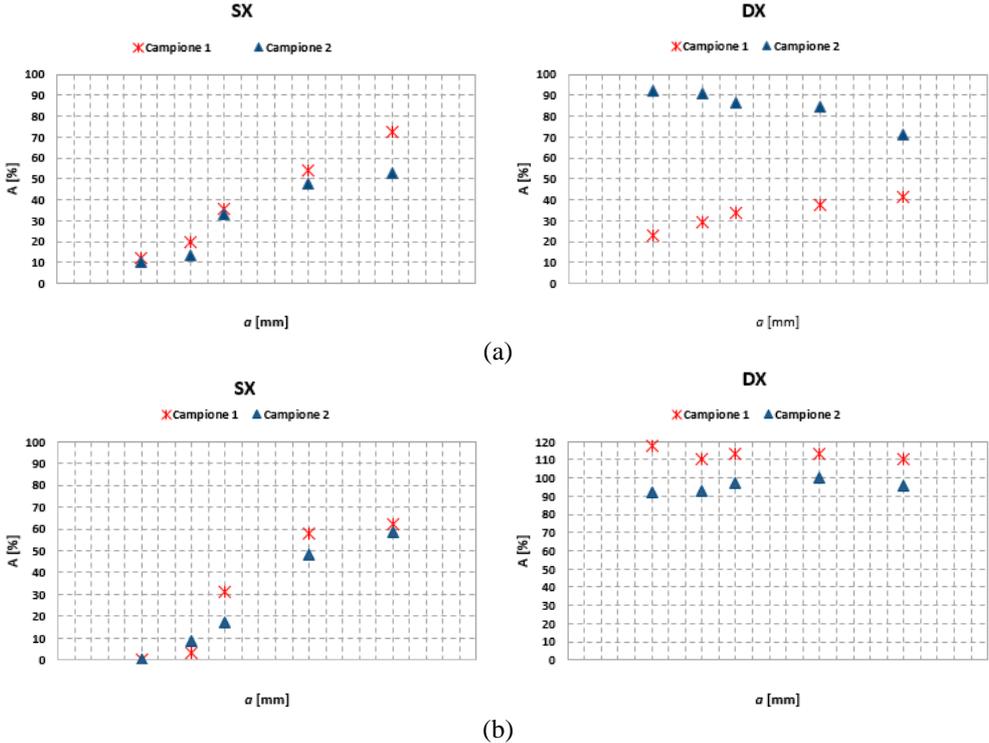
Fig. 6. Summary of the obtained a vs. \hat{a} responses: a) from rolling surface; b) from foot upper surface.

Figure 6 summarizes the obtained a vs. \hat{a} responses. As can be seen, the DX approach is not acceptable and not consistent. It is difficult to think to the possibility to derive meaningful POD curves by the DX approach. The reason can be ascribed to the heterogeneous and coarse microstructure usually characterizing this type of weld and heat affected zones. On the other hand, the SX approach seems to provide, from the two inspected samples, good, consistent and comparable data, allowing for the determination of POD curves. The conclusion, which can be drawn, is that inspections should be carried out from both sides of the weld to maximize reliability.

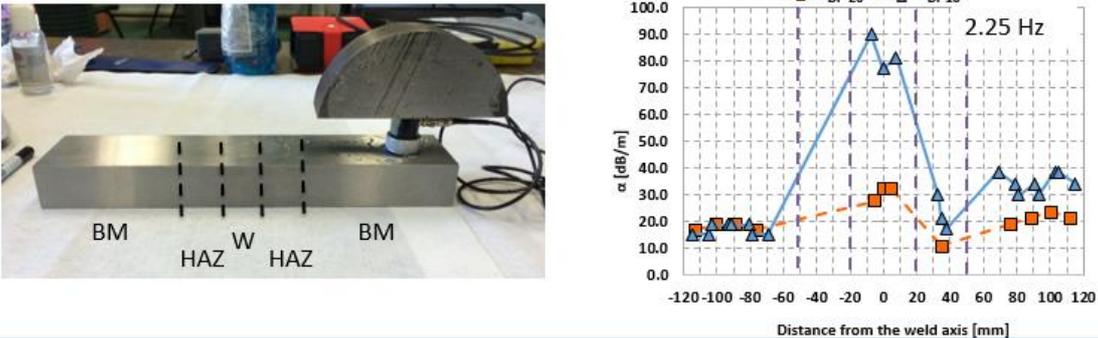
Fig. 7. Experimental characterization of structural attenuation.

The final experimental activity dealt with the characterization of structural attenuation for both to clarify the just described behaviour of DX inspection and to implement it into the following numerical models. Both longitudinal and shear waves were characterized. Figure 7 shows the experimental set-up and the obtained results in the case of longitudinal waves inspected by two different normal probes characterized by a different diameter of the crystal (DP20: $\varnothing=20$ mm, DP10: $\varnothing=10$ mm). The sample block was machined from a real welded joint and allowed characterizing the structural attenuation for the base material (BM), heat affected zones (HAZ) and weld (W). Indeed, results showed a significantly higher structural attenuation of the welded material with respect to the heat affect zones and the base material.

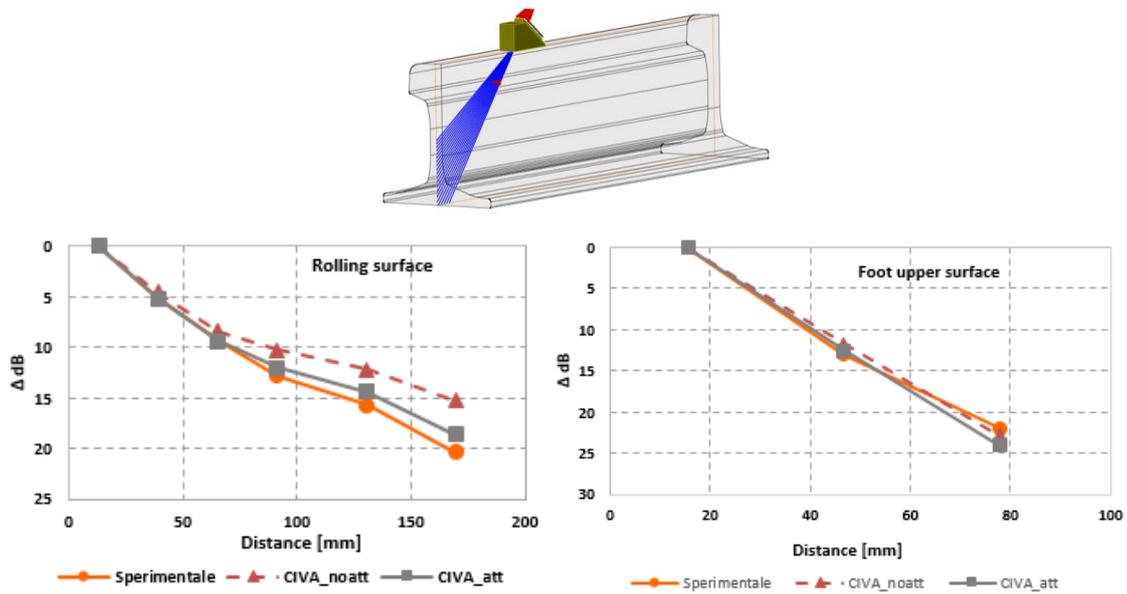
Fig. 8. Calibration of the numerical model.

The available experimental data are too few to provide a reliable determination of POD curves, so a MAPOD approach ([7]-[8]) was adopted. The numerical simulations reported in the present paper were carried out by means of CIVA^{nde} 11.0 dedicated software package [9]. First, the calibration of the model was achieved by simulating the real calibration procedure used for in-service inspections: it is based on two rails, without any weld, with six SDH (diameter = 5 mm) located at different depths. PAUT responses were obtained in terms of dBs needed to get 80% screen amplitude. Analyses were carried out both with and without structural attenuation in order to check the sensitivity to this parameter. Figure 8 shows the results obtained for both the rolling surface and the foot upper surface. As can be seen, in the case of the rolling surface, it seems mandatory to keep into account for the structural attenuation in order to get a good calibration, while, in the case of the foot upper surface, it does not seem to be necessary, likely due to the much shorter sound path into the material.

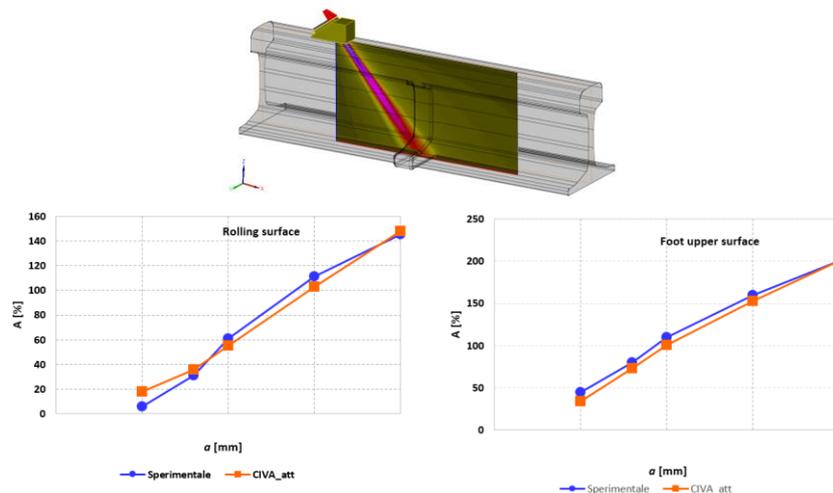
Fig. 9. Validation of the numerical model.

The calibrated model was, then, validated by simulating all the experimental inspections carried out on the welded samples and keeping into account for structural attenuation. Figure 9 shows the successful results of the validation.

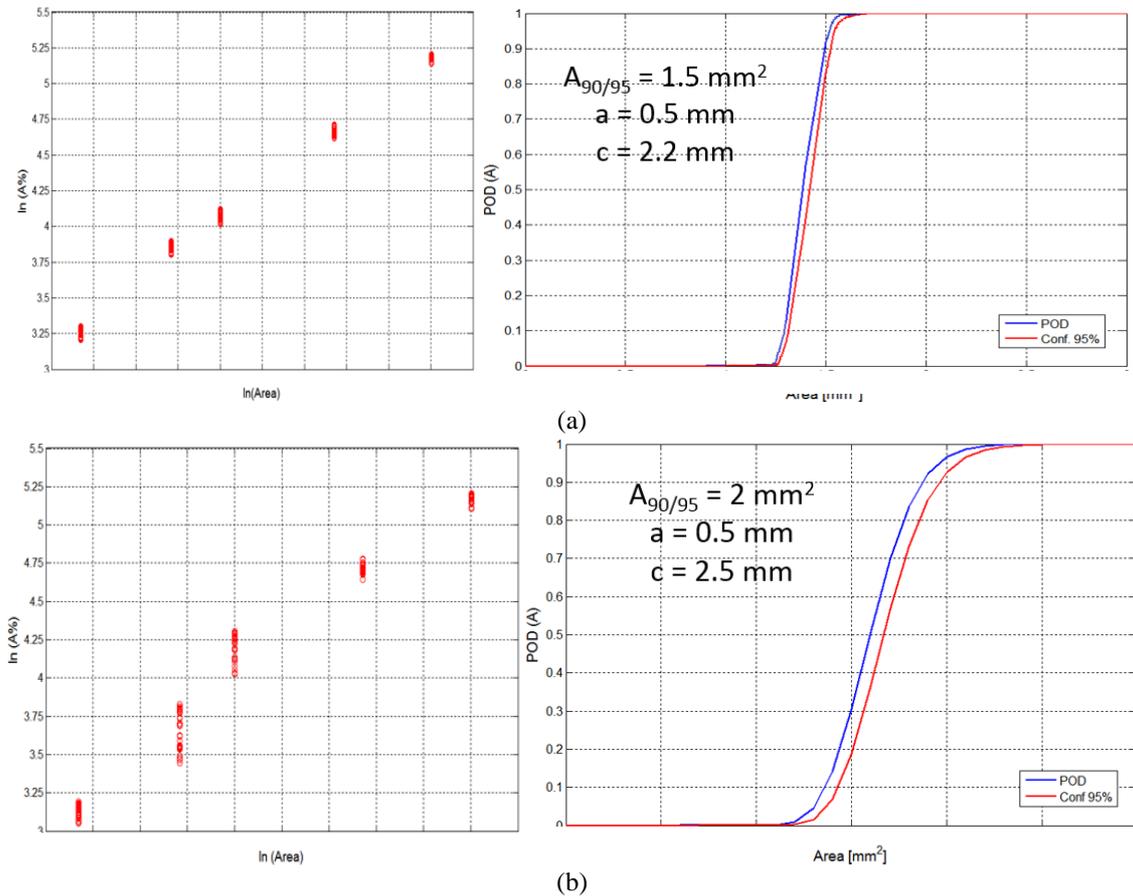
Fig. 10. MAPOD curves: a) from rolling surface; b) from foot upper surface.

Figure 10 reports the obtained MAPOD curves. As can be seen, the performance of inspections from the rolling surface seems a bit better than that from the foot upper surface. This can be expected because the foot upper surface is not parallel to the foot base and because, contrarily to the rolling surface, it is not machined after the manufacturing of the weld and, consequently, its roughness is much worse.
