**18<sup>th</sup> WCNDT**  
16-20 April 2012  
Durban, South Africa

## **APPLICATION OF EDDY CURRENTS TO THE INSPECTION OF FATIGUE-CORRODED RAILWAY AXLES**

Michele Carboni

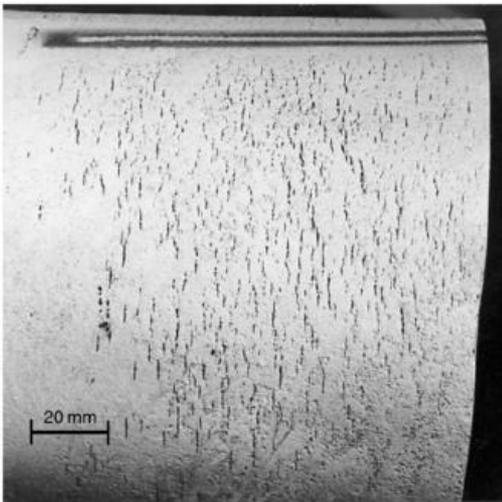
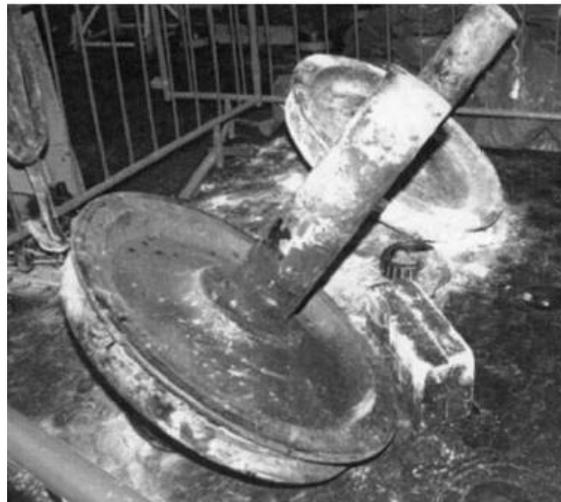
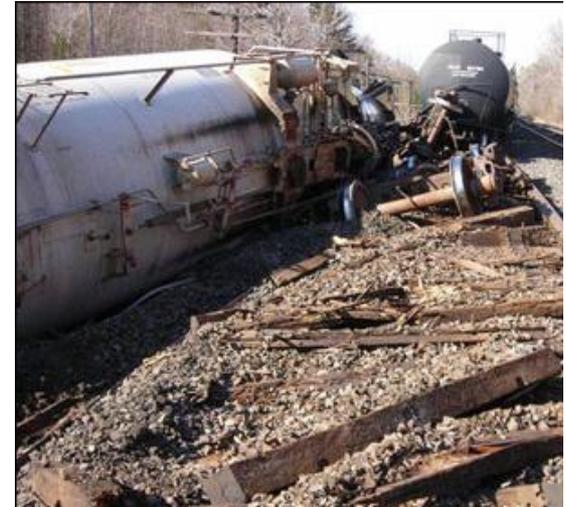
- ✓ **Corrosion-fatigue**: simultaneous and synergic application of a corrosive environment and cyclic loads
- ✓ Some documented **failures** of railway axles due to corrosion-fatigue:
  - 08/03/1996 Stafford
  - 29/01/1998 Scotland
  - 21/06/2002 Nottingham
  - 1998-2000 reported by the Transportation Safety Board of Canada
- ✓ Examples of **damage** and **failures** due to corrosion-fatigue

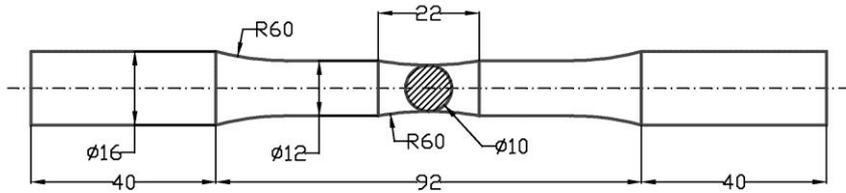
✓ Specimens geometry

- Experiments on small-scale specimens (A1N)
- Numerical simulations

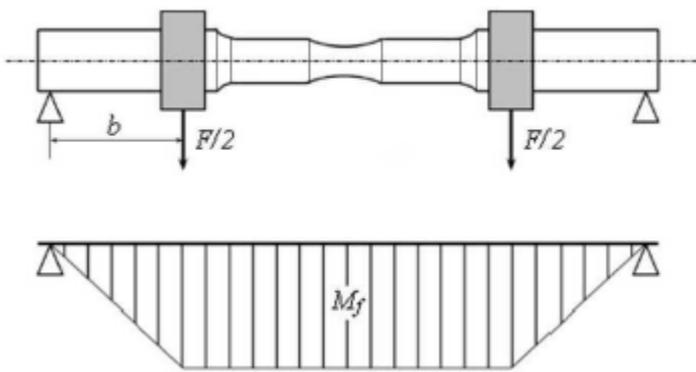
✓ Rotating bending moment (4pb)

- $\Delta\sigma = 400$  MPa
- *Rotating speed* = 600 rpm

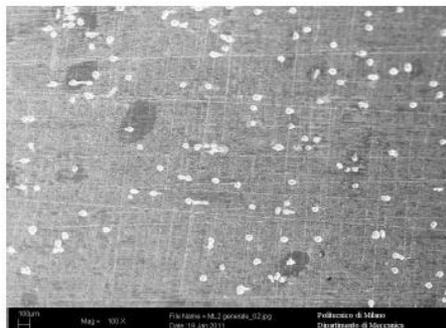
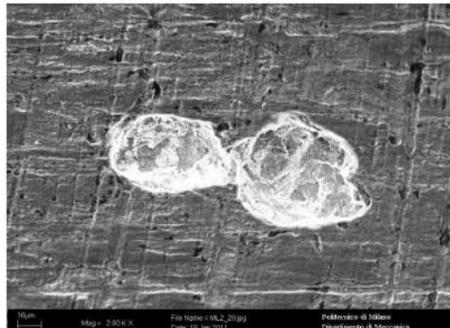
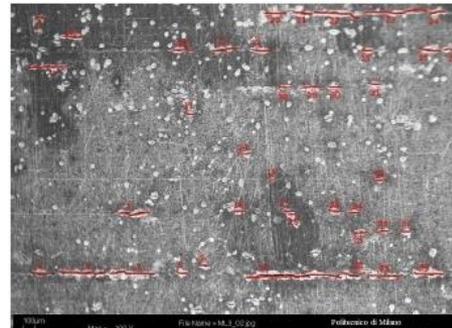
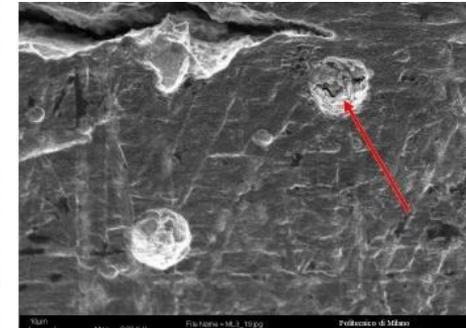
Specimen **ML3** (200.000 cycles)

- Crack initiation at 200.000 cycles at  $\Delta\sigma = 400$  MPa
- Different stages of coalescence
- Eddy currents
  - differential probe better than absolute one
  - increasing response till a stabilised value
  - saturation due to very complex damage pattern

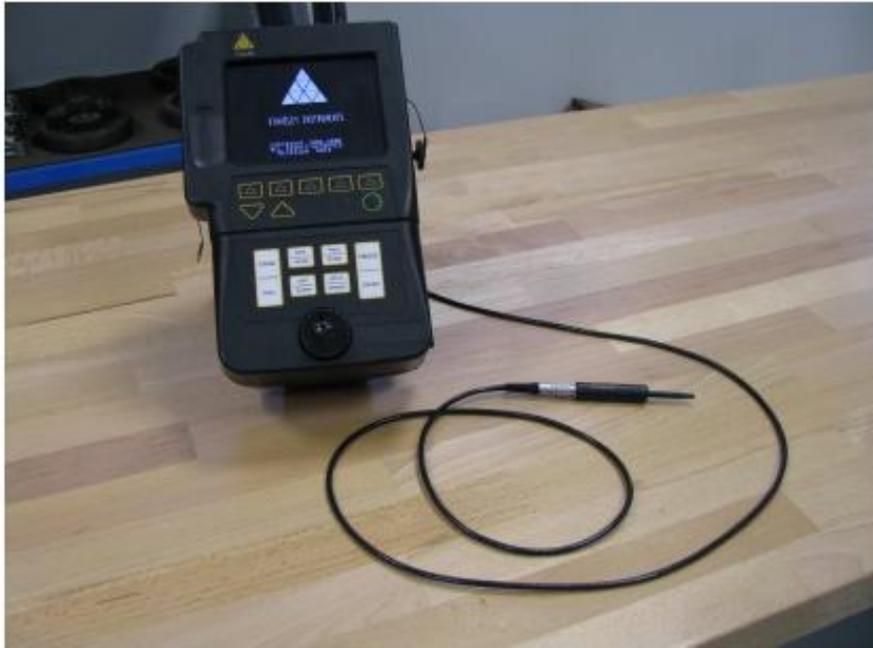
- ✓ Nortec 1000S+

The calibration of the working frequency was carried out using an artificial known defect located on a specimen made of A1N

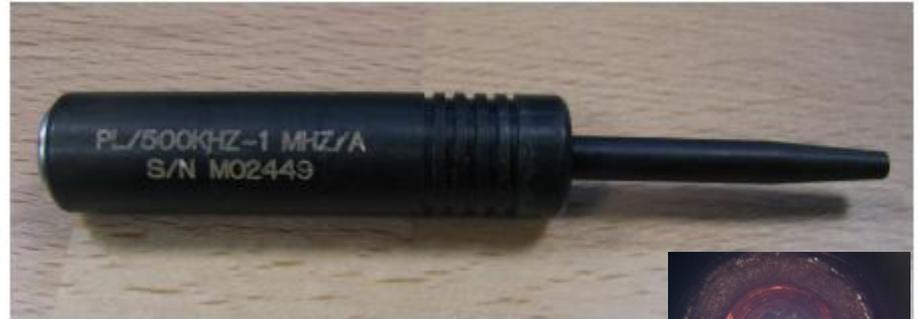
- ✓ Absolute probe

500 - 1000 kHz: 500 kHz

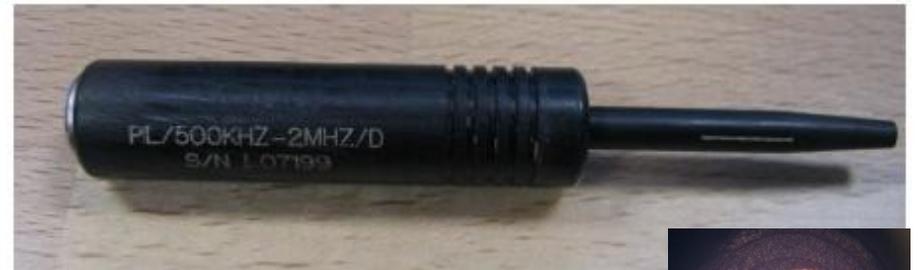
- ✓ Differential probe

500 - 2000 kHz: 620 kHz

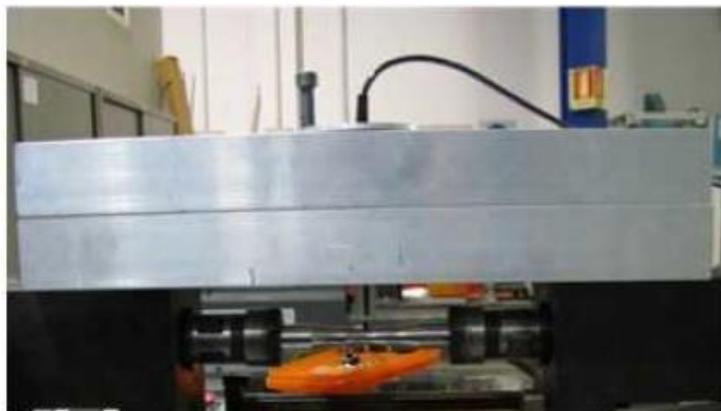
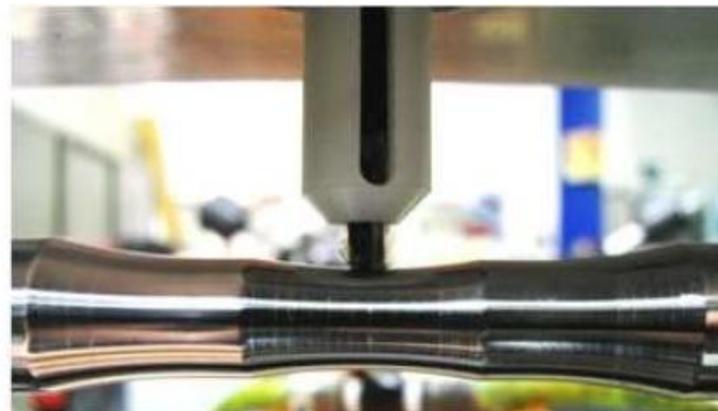
- ✓ Measurements repeatability: suitable frame and contact inspection

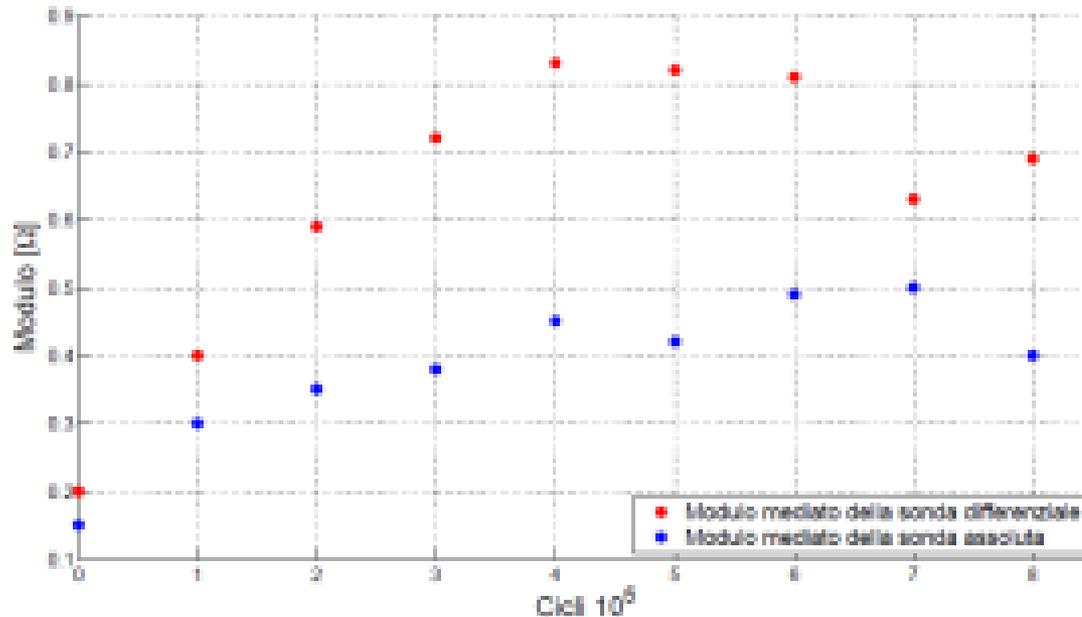
The measurements consisted in the acquisition of the eddy current response:

- along a complete **circumferential revolution** (360°) of the specimens: this means that all the prospective cracks were longitudinally inspected.
- at **1 rpm**.

- The differential probe seems to be more performing
- At 0 cycles an impedance variation could be observed
- Two regions: linear and saturated

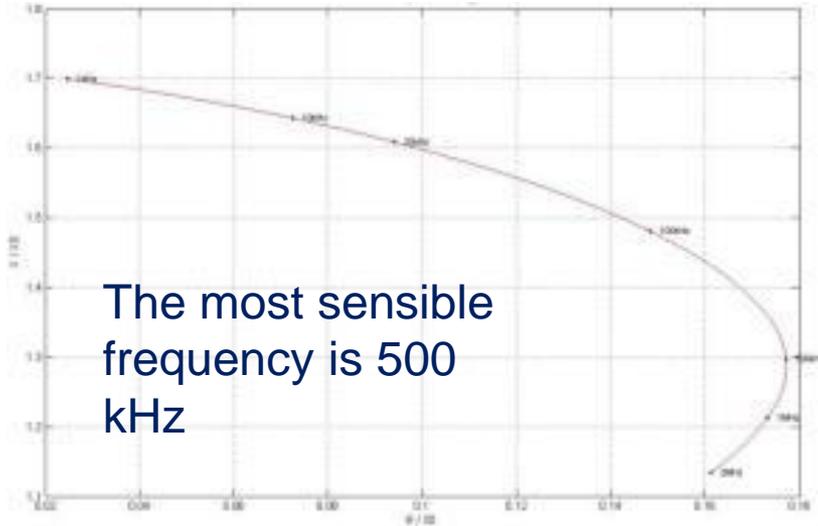
- Numerical simulations were carried out In order to interpret and understand some of the obtained experimental results by means of **CIVA<sup>nde</sup> v.10.0b**
- Only the **absolute** probe was considered
- The general geometry of the absolute probe coil was derived by a **reverse engineering** procedure based on radiography and optical microscopy, the details are **not** provided due to the proprietary nature of the information
- A 50x50x5 mm **panel** made of a general carbon steel similar to A1N grade (electrical conductivity  $s=6.2$  MS/m and magnetic permeability  $m =200$  H/m) was considered instead of the real cylindrical geometry which is not available in CIVA.

The most sensible frequency is 500 kHz

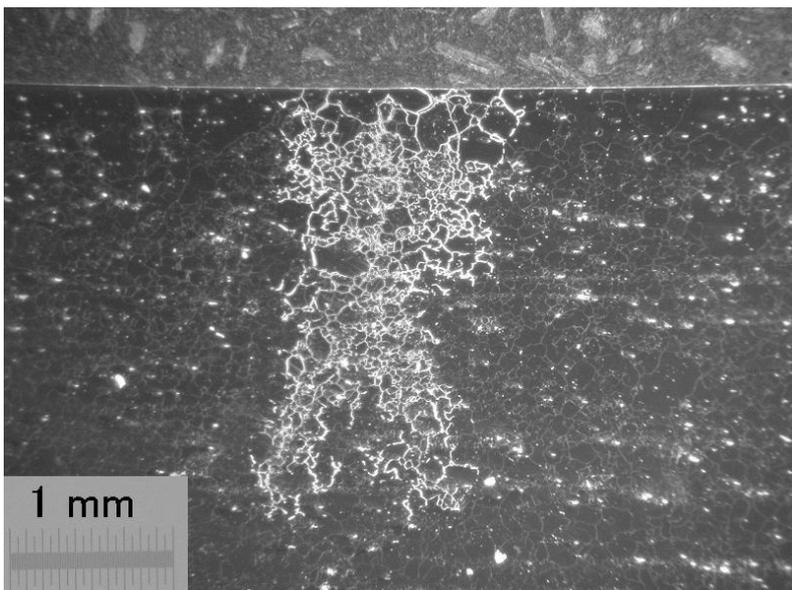
## Stress corrosion

Are low frequencies better?

- A careful numerical calibration could be obtained
- The best working frequencies for corrosion-fatigue are significantly higher than those useful for stress corrosion
- Inspection radius: multiple cracks are inspected at the same time, it is not useful to consider and to study the response of a single crack
- Scanning longitudinally a crack seems to be better than transversally
- Multi-crack simulations show good qualitative performance with respect to the module response coming from experiments

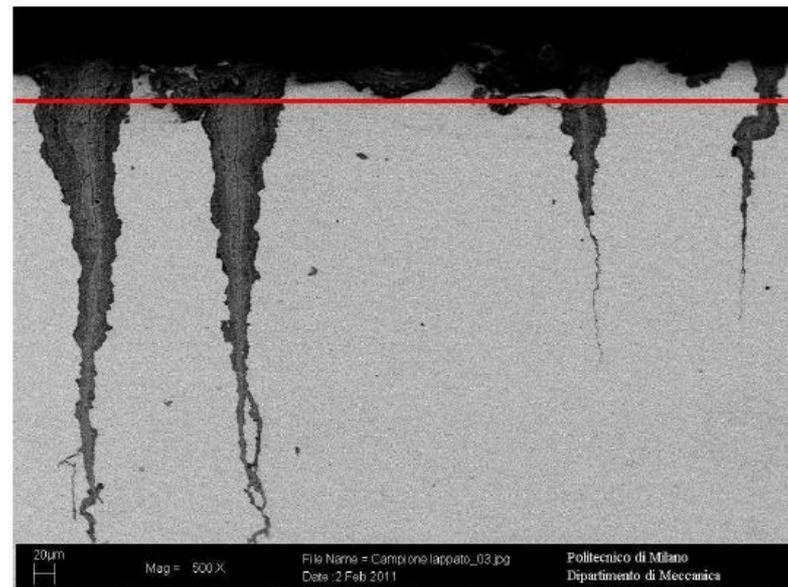
## Corrosion-fatigue

Are high frequencies better?

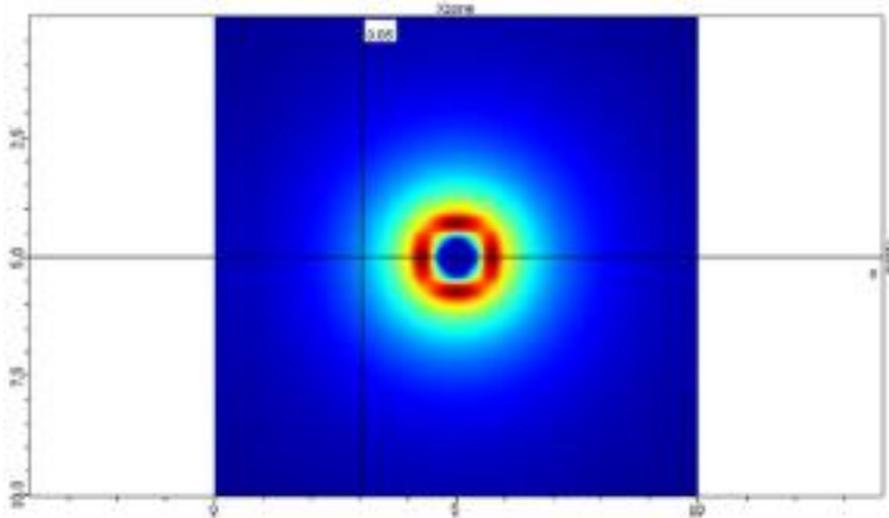
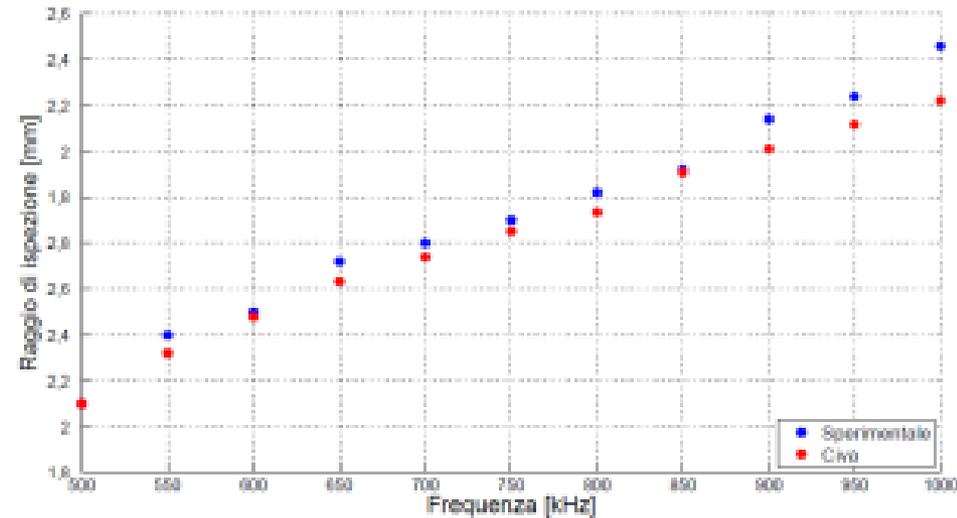
The last preliminary simulation regarded the **inspection radius**

The **inspection radius** trend is very similar between experiments and simulations varying the working frequency

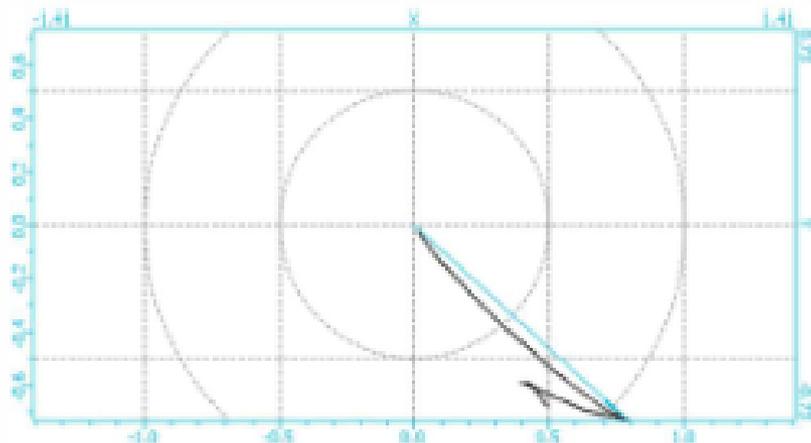
## Scanning direction

Phase:  $-43^\circ$   
Module: 1.072 mV

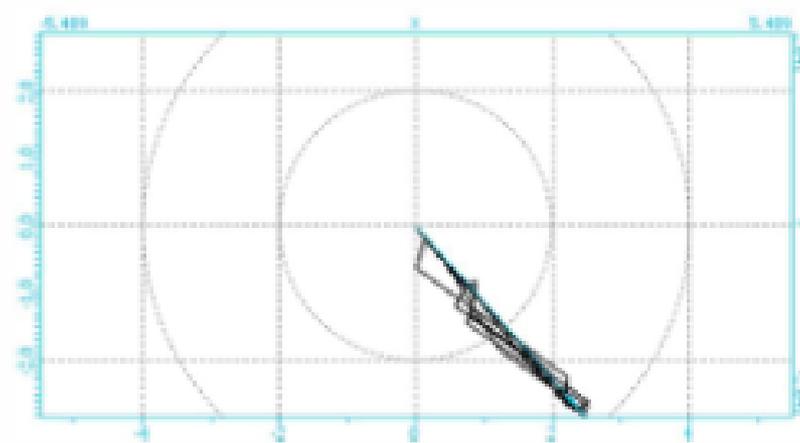
Phase:  $-49^\circ$   
Module: 3.77 mV

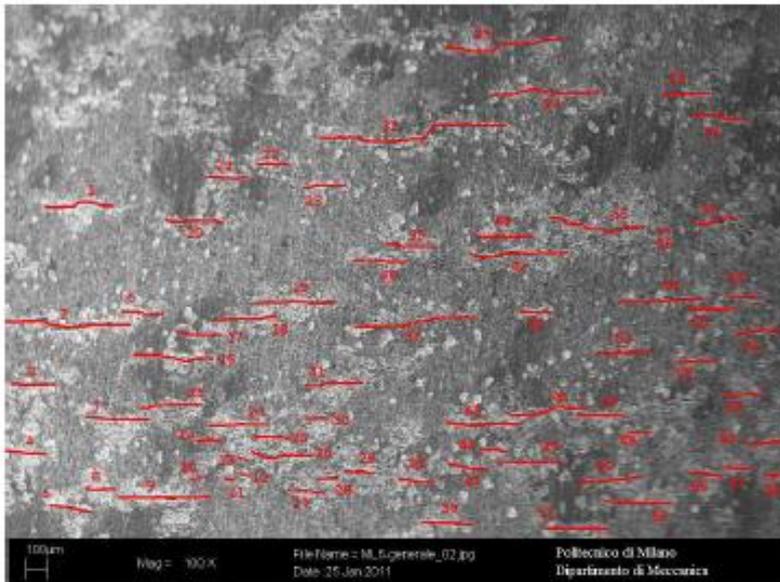
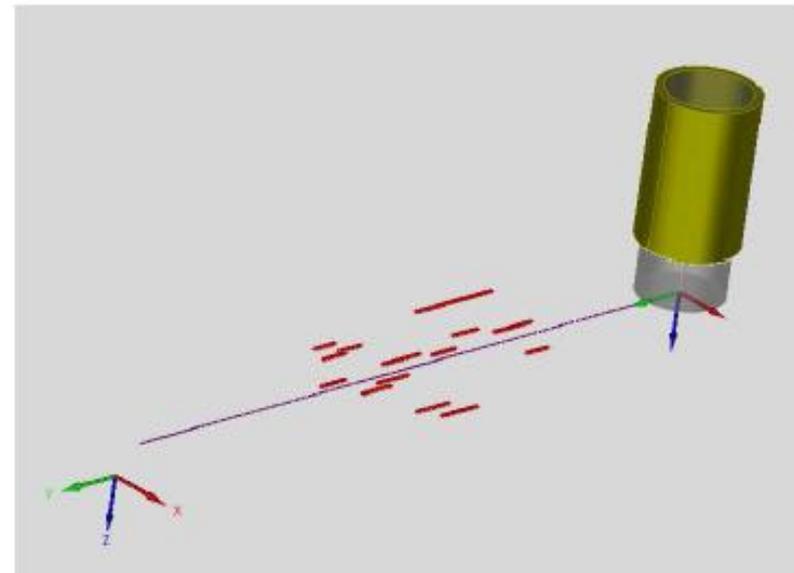
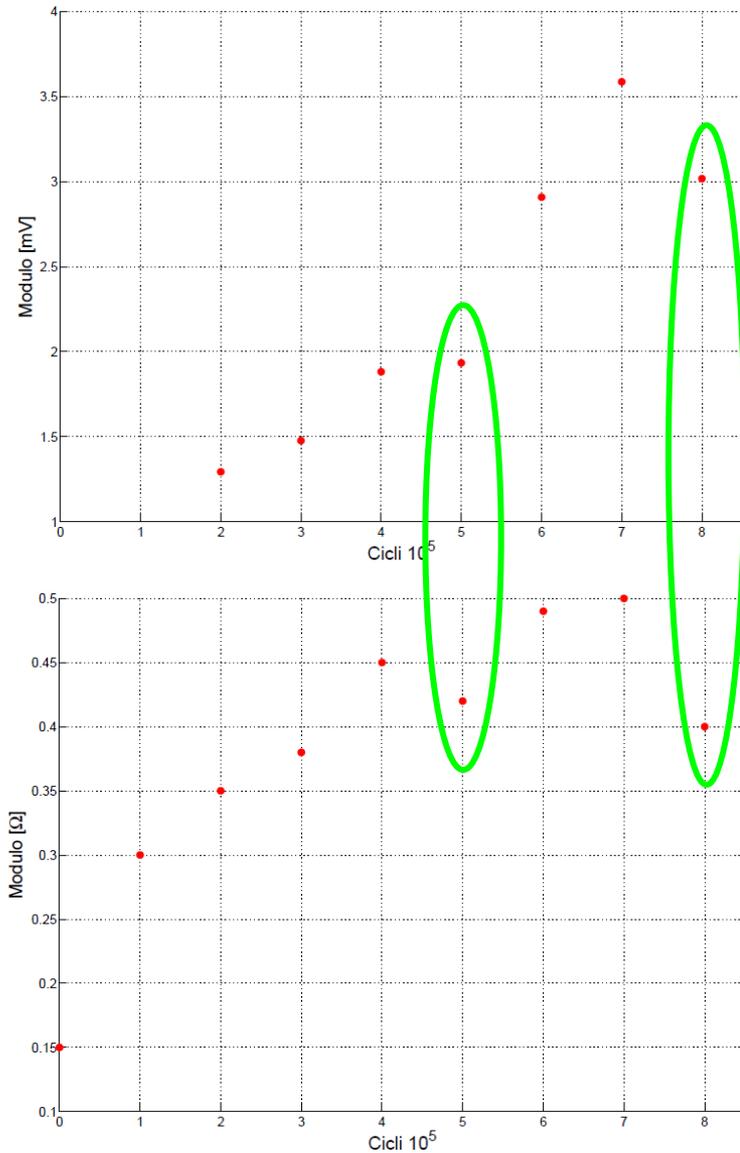
- ✓ **Multi-crack** simulation starting from defects taken from a micrograph
- ✓ The 15 longest cracks were considered

- ✓ Qualitative comparison
- ✓ Increasing linear trend
- ✓ Two not linear results
