Ultrasonic Inspection of Adhesive Joints of Composite Pipelines

Abstract. Composite pipelines are an attractive solution when traditional materials are not suitable for this purpose, which happens frequently at aggressive environments and also where the structural weight is a limiting factor. This work studies the application of the ultrasonic technique at the detection of defects as lack of adhesive and lack of adhesion, commonly found in adhesive joints of glass fiber reinforced plastic (GFRP) pipelines applied at onshore and offshore facilities. Computational simulations were conducted in CIVA 11© software (beta version) in order to obtain the best possible configuration for the inspections, applying the pulse-echo technique. Experimental results were compared to these simulations and several transducers were tested. An inspection methodology and reference blocks were developed for the calibration of the inspections. Some samples were selected for cutting in order to compare the ultrasonic results and the real condition of the joints. Results show that smaller frequencies are suitable for the inspection of this material and focused probes present more accurate results.

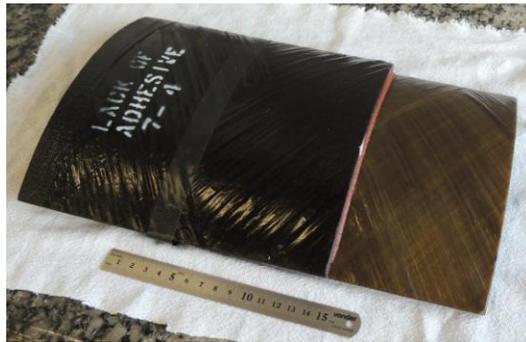
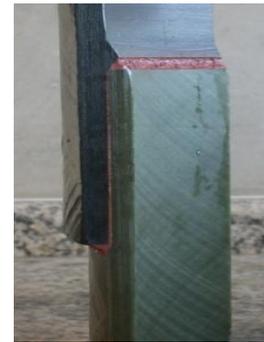
FIGURE 2. Image of the studied samples: (a) Section of a 16" diameter pipe, (b) Cross section of the overlapping and (c) Overlapping in detail.

Thirty samples that were part of a 16" diameter pipeline joint, which is composed by an epoxy matrix reinforced by glass fibers, were used for this study. The adhesive layer that connects the parts is an epoxy resin (Fig. 2). Typical

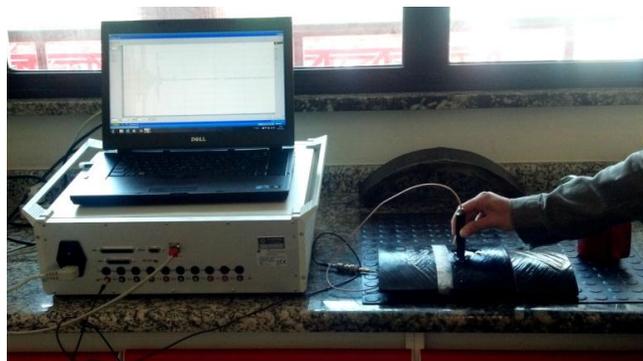
FIGURE 4. Ultrasonic pulse-echo apparatus.

The experimental procedure applied the pulse echo configuration using those same transducers frequencies. The flaw detector was a General Electric USIP 40, as shown in Fig. 4. Calibration blocks which reproduce the structure of a well bonded joint were developed in order to enable the calibration of the sensitivity of the inspections. The scanning of all specimens was carried out at a non-continuous scan since the surface and the superficial irregularities jeopardize the coupling.

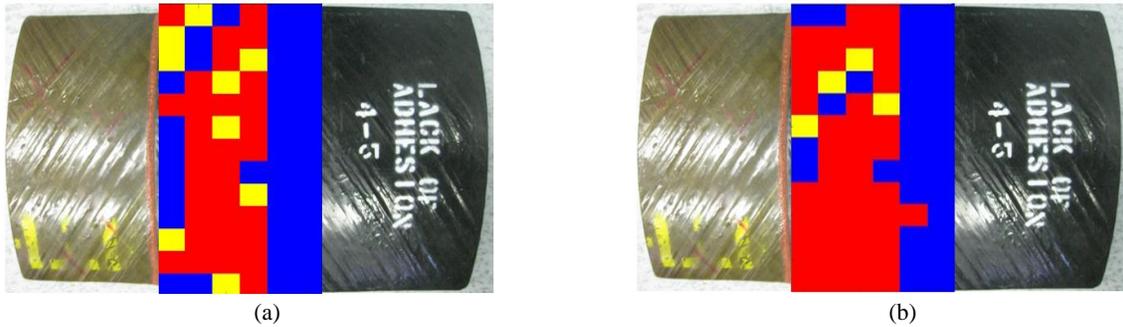
FIGURE 10. C-scans from specimens with lack of adhesion: (a) Lack of Adhesion 4-2 and (b) Lack of Adhesion 4-3

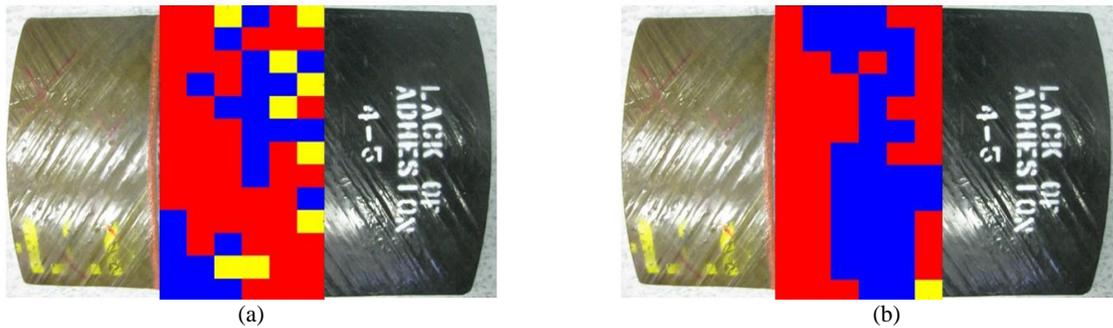
FIGURE 11. C-scans from specimens with lack of adhesive: (a) Lack of Adhesive 8-2 and (b) Lack of Adhesive 8-3
