Fundamentals of Angled-beam Ultrasonic NDE for Potential Characterization of Hidden Regions of Impact Damage in Composites

Abstract. In this study, the use of angled-beam ultrasonic NDE was explored for the potential characterization of the hidden regions of impact damage in composites. Simulated studies using CIVA FIDEL 2D were used to explore this inspection problem. Quasi-shear (qS) modes can be generated over a wide range of angles and used to reflect off the backwall and interrogate under the top delaminations of impact damage. Secondary probe signals that do propagate normal to the surface were found to be significant under certain probe conditions, and can potentially interfere with weakly scattered signals from within the composite panel. Simulations were used to evaluate the source of the multiple paths of reflections from the edge of a delamination, whose time-of-flight and amplitude will depend on the depth of the delamination and location of neighboring delaminations. For angled-beam inspections, noise from both the top surface roughness and internal features was found to potentially mask the detection of signals from the edge of delaminations. Lastly, the potential of

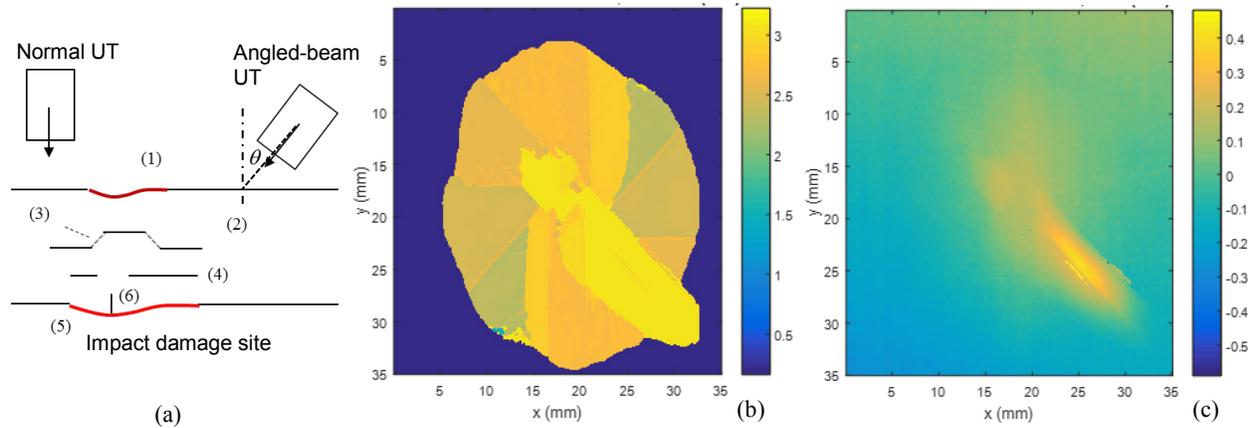
FIGURE 1. (a) Diagram of normal and angled-beam ultrasonic testing (UT) of impact damage site. (b) Time-of-flight C-scan (in depth, mm) of the far side 'hidden' delamination profile, and (c) C-scan map (in mm) of the far surface deformation.

For in-service NDE of aircraft structures, there is the need to improve NDE characterization of impact damage [4-5]. Normal longitudinal ultrasonic testing (UT) can detect the presence of delaminations and some matrix cracking through a single-sided inspection; however, this technique does not address the hidden damaged region under the top delamination front. Examples of hidden impact damage are presented in Figures 1(b) and 1(c), showing the ‘hidden’ delamination ‘rosette’ profile and back-surface deformation profile respectively (measured using normal UT from the back-side surface). To detect and characterize such hidden damage from an external surface, an angled-beam method is proposed using quasi-shear waves, both direct and reflected paths, as shown in Figure 1(a). This approach builds upon prior work investigating polar backscatter ultrasonic techniques for composites [6-9]. Although, no work has

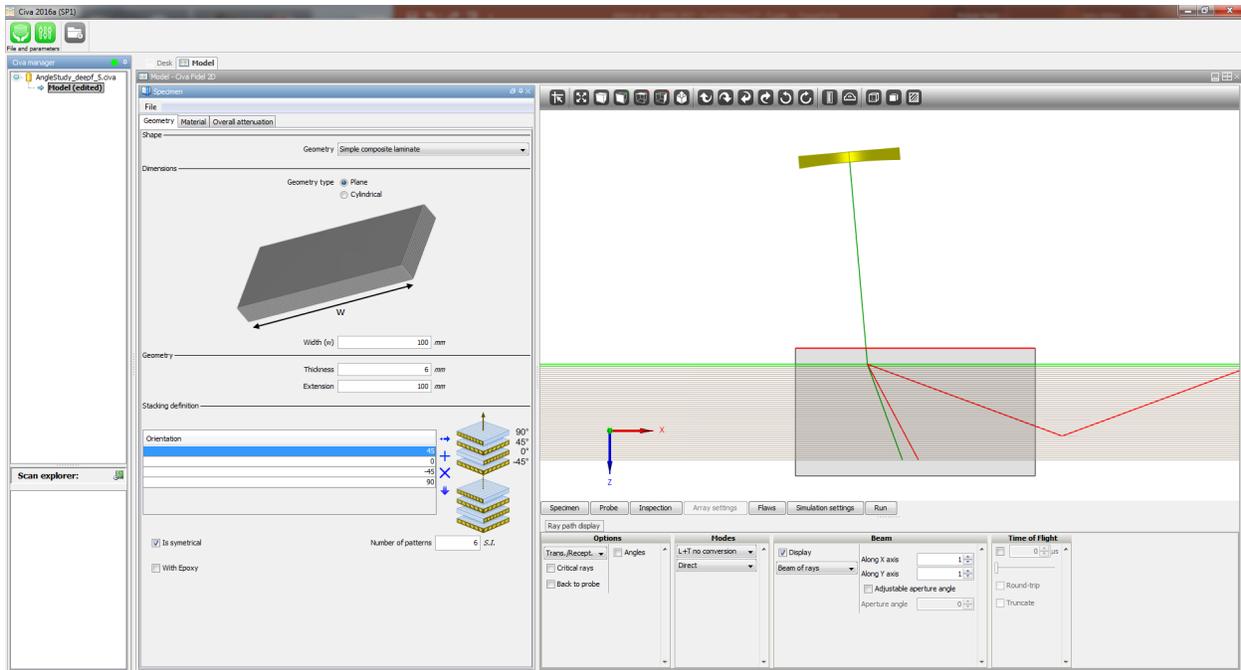
FIGURE 2. View of CIVA FIDEL 2D interface for simulation of UT NDE of composites

A promising option in CIVA 2016, called CIVA FIDEL 2D, can address this need for improved accuracy while maintaining reasonable simulation time in modeling the incident field and scattering from defects in composite inspections. CIVA FIDEL incorporates a hybrid approach using semi-analytical models for ultrasonic transmit and receiver transducers in conjunction with a 2D finite difference time domain (FDTD) solution for modeling the local interaction and scattering from multilayer composites with discontinuities [11-12]. A screen shot of the CIVA FIDEL software interface is presented in Fig. 2. The composite layers can be modeled with a wide range of flexibility on layer orientation, including thin layer of epoxy between the 'fiber with matrix' sheets. Currently, four defect types can be modeled in CIVA FIDEL: square defects, delaminations, holes and layer waviness. The user can define the size of the numerical problem by constraining the mesh domain and implemented perfectly matched layer (PML) boundary conditions. Options for the numerical model are provided to set the mesh resolution relative to the wavelength of the probe center frequency. 2D simulations are much faster compared with full 3D representations, and they generally can provide satisfactory models to understand the key trends with varying inspection parameters, presence of multiple defects with varying location, presence of plastic deformation or cracking at the backwall surface. As well, CIVA FIDEL provides some very useful features for reviewing the simulated results; it is feasible to view the peak response in the specimen domain, and step through the transient response using 2D image views. More information on the formulation and applications of CIVA FIDEL can be found in references [11-12].

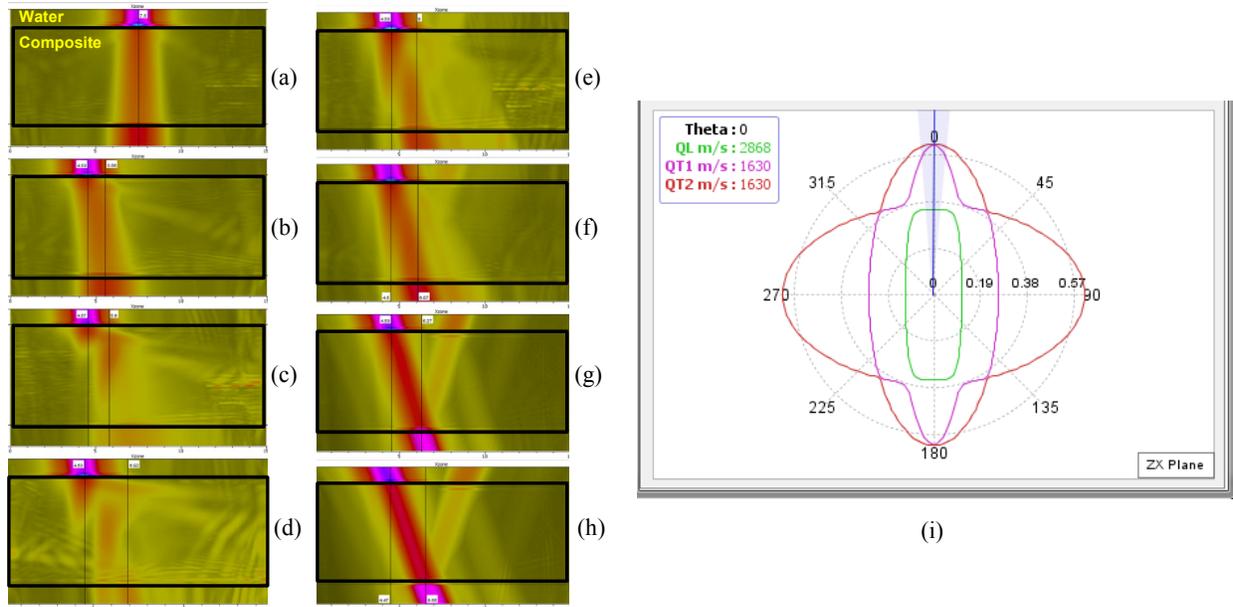
FIGURE 3: Peak beam field in the simulated composite with varying incidence angle, θ (a) 0° , (b) 2.5° , (c) 5° , (d) 7.5° , (e) 10° , (f) 12.5° , (g) 17.5° , (h) 22.5° . (i) Slowness curves of quasi-longitudinal and quasi-shear modes for the homogenized composite.

In Fig. 3(a)-(h), a series of simulations are presented for the incident beam field in the test composite for varying incident angle from 0° to 22.5° . First, since carbon-fiber laminates are inherently anisotropic, one must consider ‘quasi-longitudinal’ and ‘quasi-shear’ modes present in the composite, where the direction of wave deflection is not necessarily parallel or perpendicular to the direction wave propagation, respectively. Once the angle of incidence transitions from a normal inspection at 0° , to incident angles of just 5.0° - 7.5° , the quasi-longitudinal wave no longer propagates through the entire laminate, but is refracted strongly along certain fiber directions. At this stage, a clear quasi-shear mode appears, around $\sim 12.5^\circ$, which encompasses the vast majority of the energy into the part. Characteristics of the waves can also be explained by the slowness curves shown in Fig. 3(i). Note, these slowness curves were calculated using the homogenization method in CIVA UT [10] and thus only approximate the full numerical FDTD simulations. In the normal direction, the quasi-longitudinal wave (2868 m/s) is much faster than the two shear quasi-waves (1630 m/s). However, at oblique incidence angles around 22.5 degrees, the approximate (homogenized) quasi-shear wave speed more closely approaches the speed of the quasi-longitudinal wave speed at 0° .

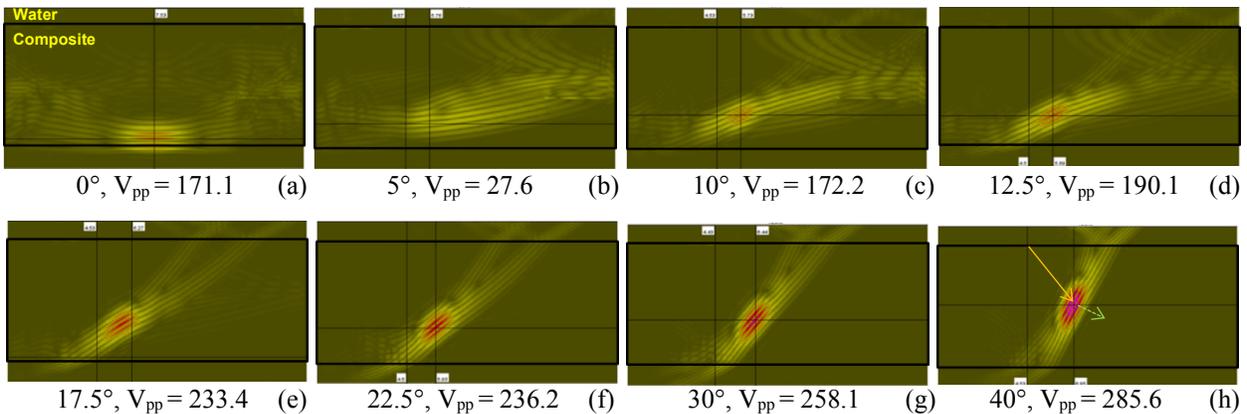
FIGURE 4. Transient beam field (at $t = 18.75 \mu\text{s}$) in a composite with varying incidence angle, θ , from 0 to 40 degrees, presenting the transition from a quasi-longitudinal wave to a quasi-shear wave.

Figure 4 shows image plots of the propagating wave-front before the back-wall and Fig. 5 shows the response after it reflects off the back-wall. It is interesting to see the angle of propagation (shown by the position of the pulse with respect to the point of entry in the composite specimens) and angle of deflection (shown by the parallel lines of the pulse shape) to not be orthogonal [see Fig. 4(h)], which is expected for quasi-shear waves through this anisotropic composite. As well, one can see the tails of the two quasi-shear modes from the main pulse propagating through the material. Quasi-shear wave signals were clearly observed out to 40° . Peak (voltage) values for the simulated pulses are included in Fig. 4 and Fig. 5. At higher angles of incidence, one does start to lose the signal with the reflected quasi-shear wave off the back-wall, due to increasing transmission into the adjacent fluid medium. The highest reflected signal ratio, comparing the signal after versus before reflection with the backwall, was found to be 0.47 at 17.5° incidence. These results generally support the observation by Johnston et al [9], where an oblique polar backscatter signal can be measured between roughly 12° to 36° for glass fiber composites.

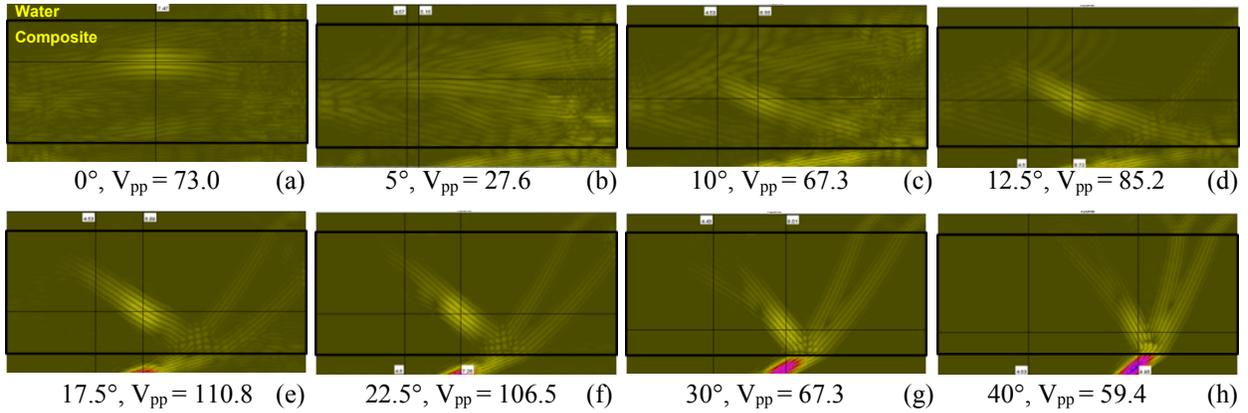
FIGURE 5. Transient beam field (at $t = 20.31 \mu\text{s}$) in a composite with varying incidence angle, θ , from 0 to 40 degrees, presenting the reflected quasi-longitudinal and quasi-shear waves from the backwall.

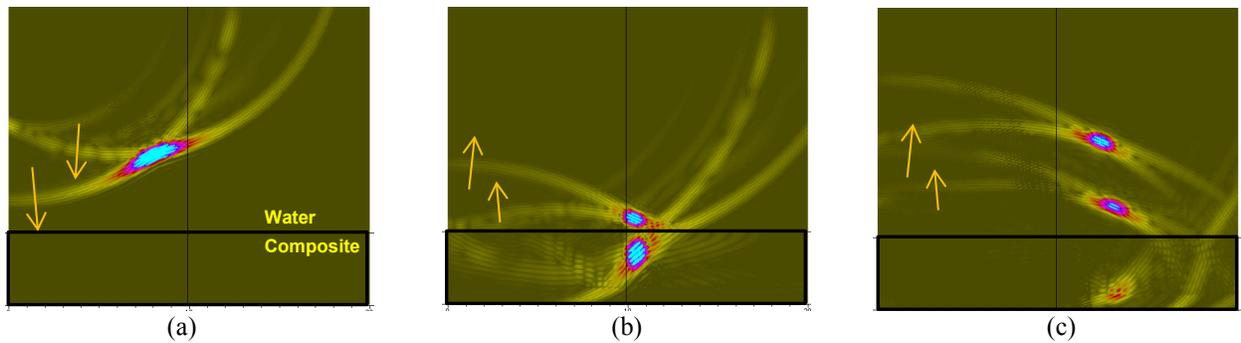
FIGURE 6. (a) Oblique beam in water incident on the composite panel. ‘Normal’ beam ‘tails’ with respect to the surface reflect back from the (b) top and (c) bottom surfaces, returning to pulse-echo transducer.

One other feature that has been observed is a weak but measurable signal that is correlated with the top and bottom surface of the composite panel. The source of this signal is due to reflections from the nearly ‘normal beam components’ (NBC) of the oblique source transducer, features of the incident field which reflect from the flat composite panel surfaces. A series of images of the simulated incident and scattered beam from a composite part are

shown in Fig. 6. These signals originate from the tails of the focused beam, as shown in Fig. 6(a), associated with a diffraction effect at the edges (boundaries) of the transducer piezoelectric element, producing two cylindrical wavefronts (from the perspective of this 2D view). The reflected signals from the top surface often return in pairs, as shown in Fig. 6(b) and 6(c). Normally, such signals are quite small relative to signals scattered by the focused portion of the beam. However, when attempting to generate a focused quasi-shear mode in a composite part and detect the primary and secondary diffraction signals from delamination edges, these reflected beam signals from the top surface can sometimes be of similar magnitude and time-of-flight as the discontinuity signals. Some studies have been performed, and it was discovered that by increasing the incidence angle, the magnitude of these reflected ‘normal beam component’ (RNBC) signals can be reduced.

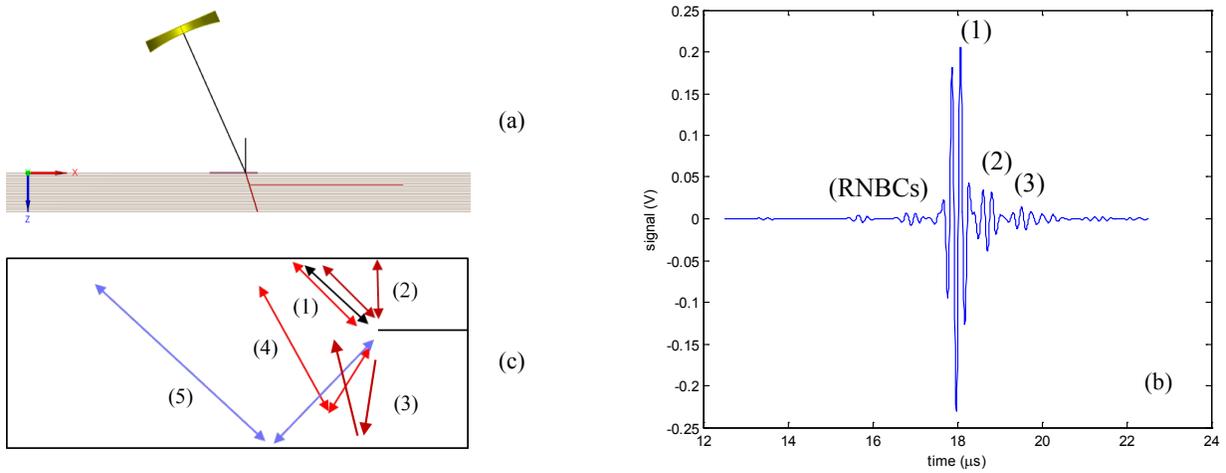
FIGURE 7. (a) Diagram and (b) A-scan signal for a 5 MHz oblique ($\theta_{inc}=24^\circ$) UT inspection at a delamination edge. (c) Ray path of key delamination edge signals: (1) direct path ($d =$ diffraction), (2) interaction with near surface ($d-b-d$; $b =$ boundary), (3) diffraction with far surface skip ($d-b$), (4) half skip with back-wall surface ($b-d$) (5) full skip with back-wall surface ($b-d-b$).

Simulated studies were also performed to better understand the scattering response from a delamination edge. A 5 MHz, 6.35 mm diameter immersion transducer with 19 mm focal length, 17 mm water path at 24 degrees oblique incidence was used for this study, shown in Figure 7(a). For this model, the delamination was located 1.0 mm down from the top surface. CIVA FIDEL was run with the probe centered on the delamination edge. The corresponding A-scan is presented in Figure 7(b). The primary signal is the direct tip diffracted signal (1), which has the shortest path for signals interacting with the delamination edge. Additional signals are observed in the A-scan and some care must be taken to identify the source and ray path. A diagram of the some of the key ray paths interacting with the delamination edge is shown in Figure 7(c). As well, a series of simulated 2D image plots are presented in Figure 8 for the focused beam quasi-shear wave incident at the delamination edge, and seven subsequent time steps, providing insight on the local scattered response. Prior to the direct edge diffraction signal in time, several smaller signals are observed in the A-scan. The source of these earlier signals is due to reflected normal beam component (RNBC) from the source transducer, discussed in the prior section. The reflected signals returning from the top surface do return in pairs, as shown in the A-scan in Fig. 7(b). In Fig. 8(a), one of these signals is shown reflecting from the top surface, just prior to the focused beam diffraction at the delamination.

With the probe beam centered on the delamination edge, several other multi-path signals can be observed after the primary direct diffraction signal. First, there is an interaction of the diffracted signal between the top surface and the delamination, signal (2), producing a signal approximately $0.75 \mu\text{s}$ after the diffracted signal. A shorthand notation for these signal paths can be used, defining the order of either the reflection off of composite panel boundary (*b*) and/or

As well, for optimizing oblique inspections for the interrogation of hidden regions of impact damage, it is important to not only optimize the response for the direct signal for improved signal to noise, but also optimize the technique for sensitivity to the full skip signal off of the panel back-wall [see the diagram in Fig. 7(c)]. Thus, an important step is to validate the SDH response with simulation, not just for the primary, direct signal scattered from the hole, but also the secondary signals that interact with both the hole and the bottom and/or top surfaces. The full skip signal reflecting from the back-wall, following the direct signal in time, is of most interest. Thus, locating these secondary signals in the B-scans (in both time and space) after finding the primary signals is critical. Figure 9 presents an example of this comparison for an oblique (42 degree) 2.25 MHz focused probe. Note, poor signal-to-noise in the experimental results, and the general complexity of the signal interpretation problem has made quantitative comparisons difficult to date. More recent work on model benchmarking and full-skip signal identification can be found in references [14-15].

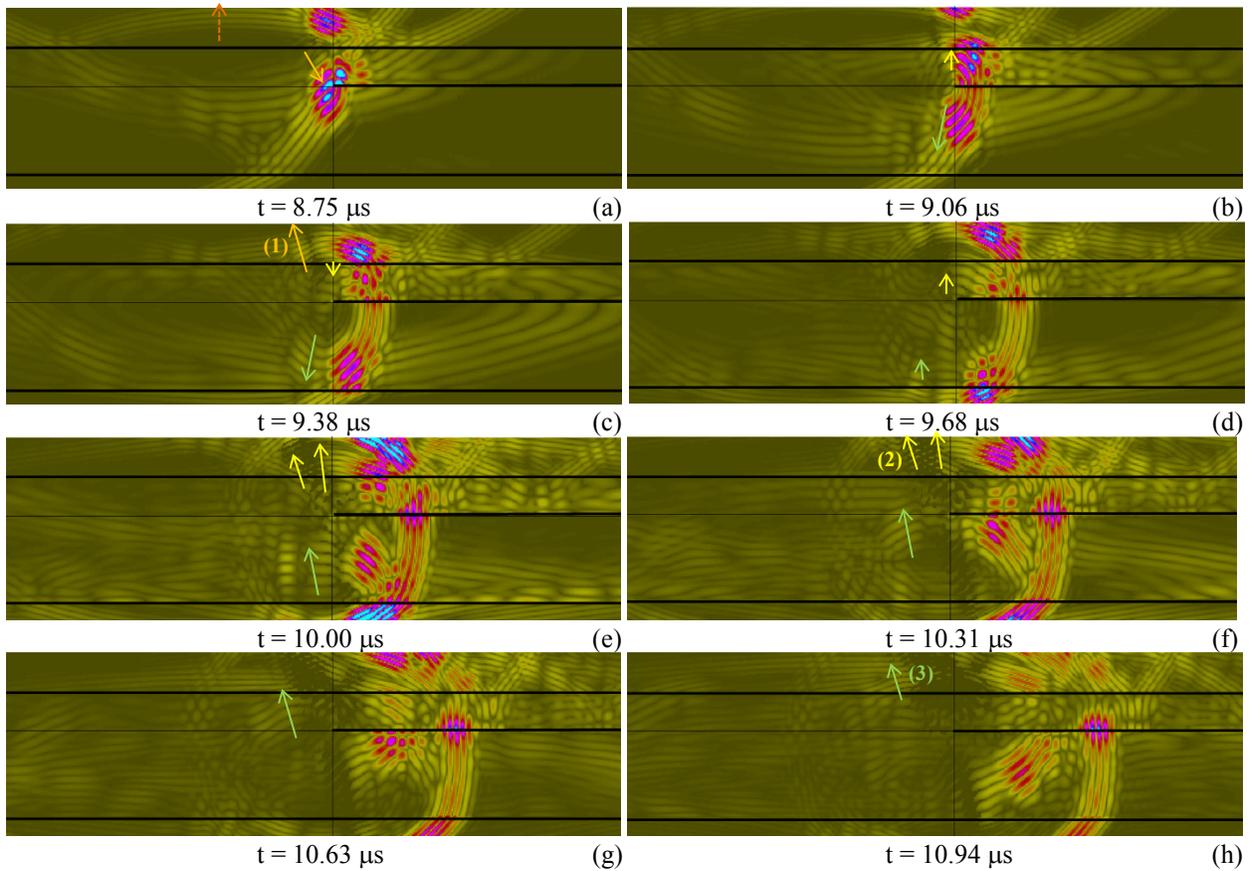
FIGURE 8. Series of simulated 2D results of incident quasi-shear wave scattering from a delamination edge for 8 time steps (a)-(h), highlighting (1) direct diffraction (d), (2) interaction with near surface ($d-b-d$) and (3) diffraction with far surface skip ($d-b$).

diffraction from the delamination edge (d). Thus, the shorthand for the first following signal is ' $d-b-d$ '. This path can be observed in Fig 8(b)-(8f). Next, there is another path for the diffracted signal (3) which first diffracts from the edge

and then reflects from the bottom panel surface back to the transducer [path '*d-b*', as shown in Figure 8(b)-(h)]. This second multipath signal is smaller in magnitude than the first, and is found in time approximately 1.5 μ s after the primary diffracted signal. Lastly, other potential multiple signals are possible, but require the transducer to be positioned back from the transducer. These signals are defined as (4) the half skip signal with the back-wall surface ('*b-d*'), and (5) the full skip with multiple reflections from the back-wall surface ('*b-d-b*'), as shown in Fig 7(c). Of most interest, to interrogate the shadow region of the delamination, the full skip signal (5) provides the best opportunity to send ultrasonic signals under the front delaminations, and subsequently detect returning signals from hidden delamination and/or matrix cracks. However, the signal magnitudes are expected to be small, relative to the primary diffracted signal (1).

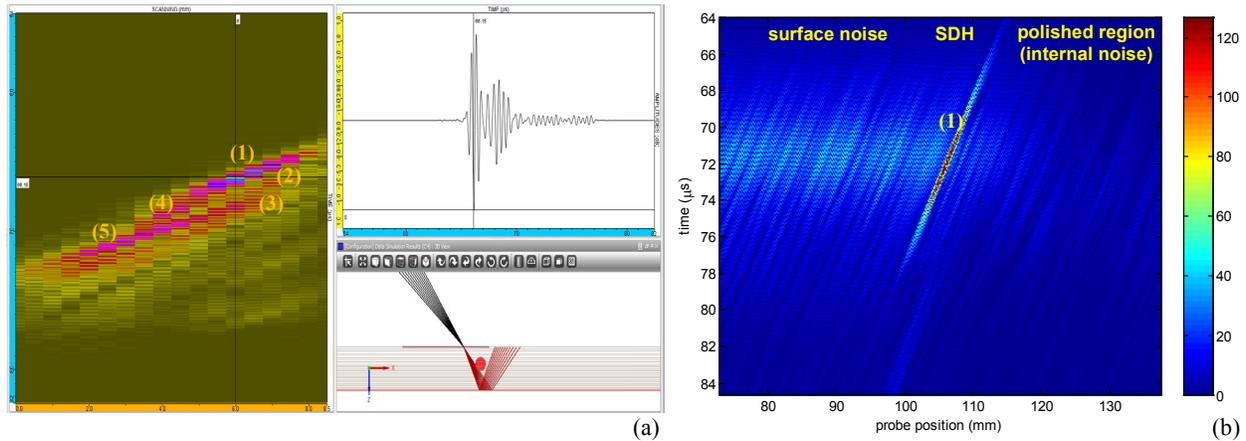
FIGURE 9. (a) CIVA Fidel 2D simulated results and (b) experimental B-scan results for an oblique (42 degree) 2.25 MHz focused 0.5" dia. (38.1 mm focal depth, 33 mm WP) UT scans from a side-drilled hole (SDH).

Second, there is a need to verify the measurement model using a known standard discontinuity. For this effort, a side drilled hole (SDH) was proposed for use as a standard defect. Such reflectors are much larger than delamination edges and are expected to have better agreement with simulated results as well. One example is presented in Fig. 9 for a B-scan of a SDH using a 42° oblique 2.25 MHz focused 0.5" dia. (38.1 mm focal depth, 33 mm WP) transducer. For this study, the SDH was 0.96 mm in diameter and located 1.02 mm from the top surface. Through early work with experimental specimens, it was observed that operating at typical frequencies for normal ultrasonic scans of composites, 5 and 10 MHz, produced quite poor signal-to-noise for oblique UT inspection of composites. A designed experiment was performed to study the sensitivity of varying probe conditions and optimize the response from side drilled holes with respect to the various noise signals present in the part. For the experimental results shown in Fig. 9(b), significant surface and internal materials noise signals are observed, even when using a lower frequency 2.25 MHz transducer. More details on recent designed experimental studies for this inspection problem can be found in reference [13].

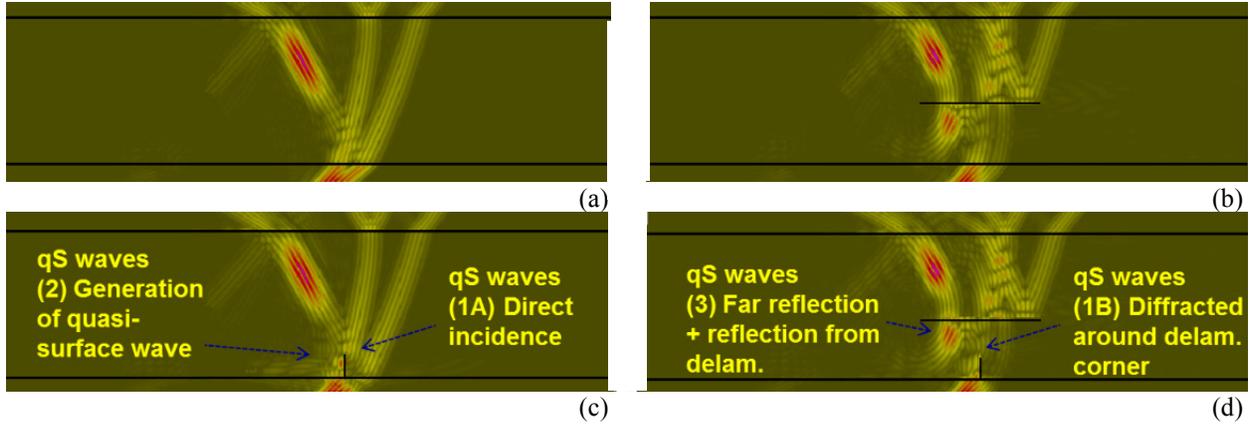
FIGURE 10. Image plot of incident field at time 22.03 μs , in a composite panel for four discontinuity scenarios: (a) no delamination or far crack, (b) delamination only, (c) far crack only and (d) delamination with hidden far crack.

The detect of far surface matrix cracks located in the backwall plastic deformation zone of impact damage are a unique challenge for external surface NDE techniques. This section explores the possibility of sending ultrasonic waves into composite panels, considering possible surface/guided waves that could propagate along the back-wall surface into the hidden region of the delamination, and interrogate this region for delaminations and/or matrix cracking. Figure 10 shows results for four simplified impact damage scenarios: (1) no delamination or crack, (2) with delamination only, (3) with crack only and (4) with delamination and crack in hidden region. In this study, a quasi-shear wave was generated using a 5 MHz, 40 degrees incidence beam in water. Figure 10 shows a single time step of the quasi-shear wave incident field interrogating the delamination region. The gain was increased in the plots to be able to highlight certain subtle features of the inspection. One characteristic is that there are two quasi-shear wave tails that ride along the top and bottom surfaces. While initially, there was some thought that these two waves are related to the two different quasi-shear modes in anisotropic materials (from slowness curve model), these signals were verified to be associate with the cylindrical wave tails of the probe beam (as shown in Figure 6). There are many interesting features to mention as the quasi shear wave interacts with the four different flaw scenarios. One can see the effect of the delamination in a number of ways, scattering the reflected signal from the far wall and generating diffractions as quasi-shear modes. Figure 11 shows a second snap-shot in time of the scattered field much later in time. Without the delamination above it, there is a strong diffracted (and corner reflection) crack signal that returns back toward the transducer, as shown in Fig. 11(c). However, some returning signals can also be found with the crack is hidden under the delamination, as shown in Fig. 11(d). However, this return signal is just more complex when it originates from a crack hidden under a delamination. As well, the returning signals are also smaller in magnitude. Special care will be required to detect such weak signals in practice. One other observation is that it is very difficult to resolve signal changes on the right side of the impact damage due to the presence of the small crack. This indicates the real challenge of attempting to use a multi-transducer pitch-catch approach for hidden damage characterization.

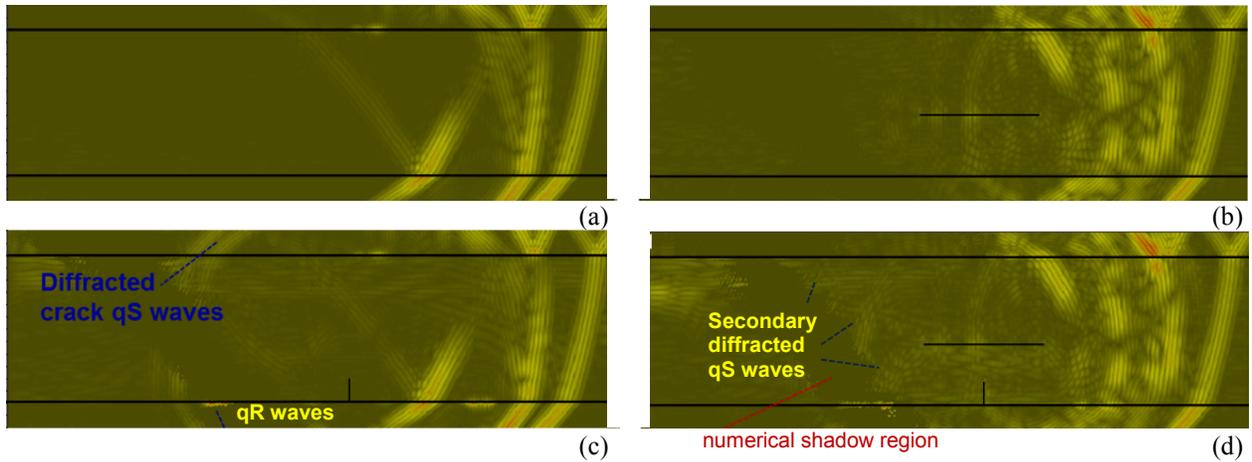
FIGURE 11. Image plots of scattered field at time 22.81 μs , in a composite panel for four discontinuity scenarios: (a) no delamination or far crack, (b) delamination only, (c) far crack only and (d) delamination with hidden far crack.

Lastly, one goal of this study was to explore the question of whether it is feasible to generate a quasi-Rayleigh (qR) wave on the back surface of the composite. This signal was observed, especially later in time after interaction with the crack, as shown in Figure 11(c). It appears to be slower than the qS modes, which is expected. As well, it does not appear that a significant qR wave is generated until after the waves interact with the crack. The one issue from the perspective of ultrasonic inspection is that the qR wave does not 'leak' back into the composite. This is reasonable (in hindsight) since Rayleigh waves on flat surfaces are not expected to leak energy into the material. One can potentially observe coupling between the far and near surfaces for surface waves, however, not at the higher frequency (5 MHz) for this simulated study. Although, due to poor generation and no observed leaking of the qR wave, this does not negate the viability of this inspection technique. There is still a significant generation of a 'quasi-

shear wave' front that interacts with the bottom surface (as well as additional signals that reflect between the backwall and the delamination) and is observed to propagate back up to the top surface for detection. In summary, it is feasible to generate quasi-shear waves to inspect the hidden delamination region. Future work is planned to implement model-based inversion to address this rather complex data interpretation task
