*Review of Progress in Quantitative  
Nondestructive Evaluation*

# Ultrasonic Inspection of Adhesive Joints of Composite Pipelines

Evaluate the application of the ultrasonic technique at the detection of defects as lack of adhesive and lack of adhesion, commonly found in adhesive joints of GFRP pipelines applied at onshore and offshore facilities.

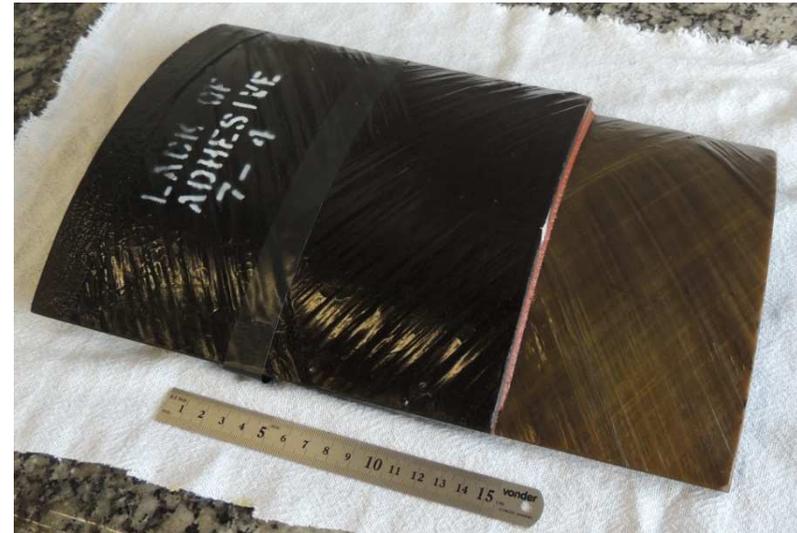
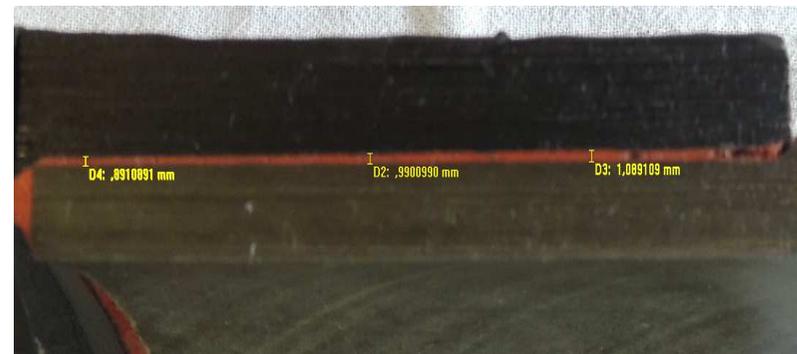
- 16" diameter GFRP pipeline joint: epoxy + glass fiber
- Through wall thickness: aprox. 20mm
- Adhesive layer thickness: aprox. 1mm

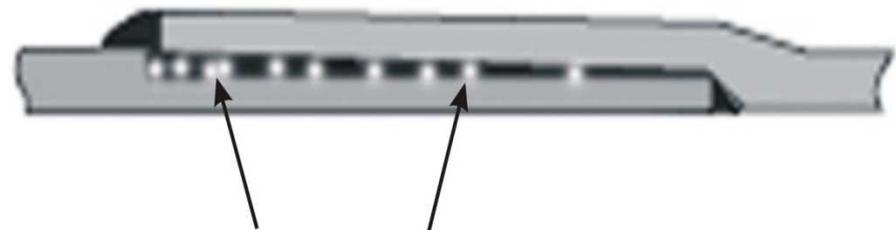
### Simulated Lack of Adhesive

Lack of Adhesive: Areas with absence of the adhesive layer.

Areas without adhesive

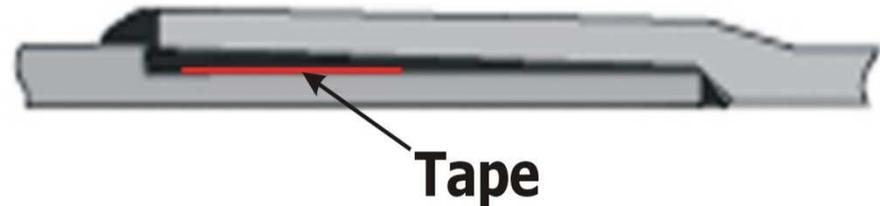
### Simulated Lack of Adhesion

Lack of Adhesion: foreign body that prevents the direct contact between the adhesive layer and the pipe's surface.

Tape

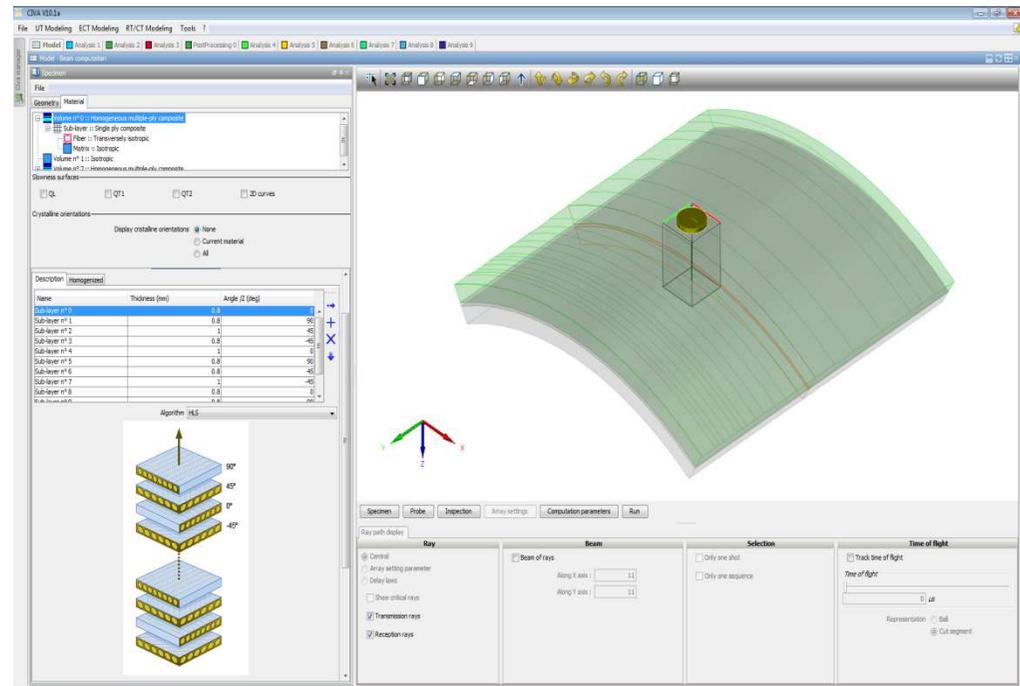
Ultrasonic Module of  
CIVA<sup>®</sup> 11 beta version.

Simulation of GFRP  
structure and  
commercially available  
transducers.

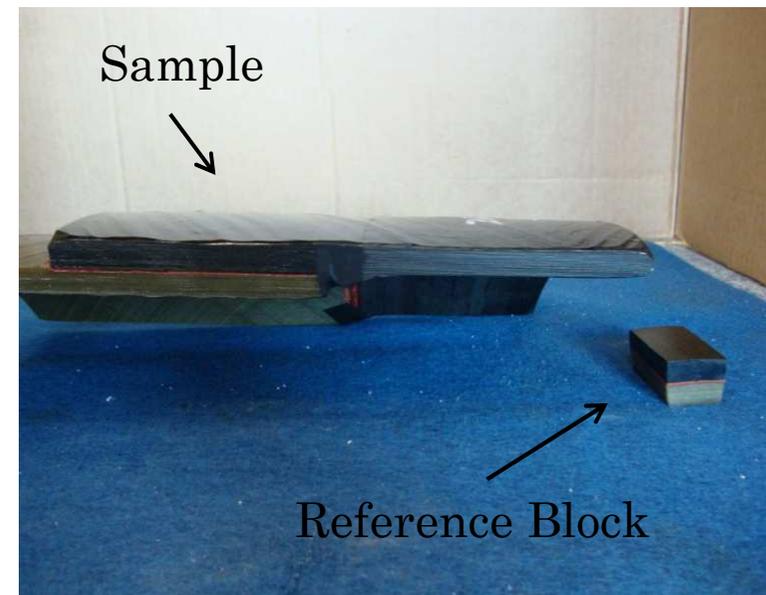
This block has the  
same cross section as  
the inspected samples.

Sample and its reference block

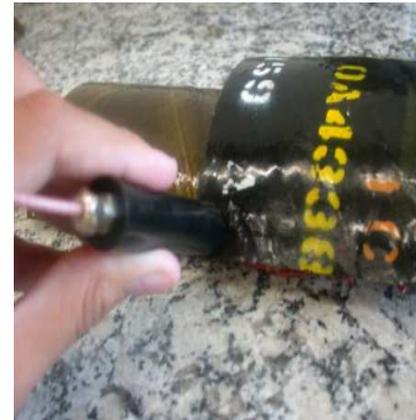
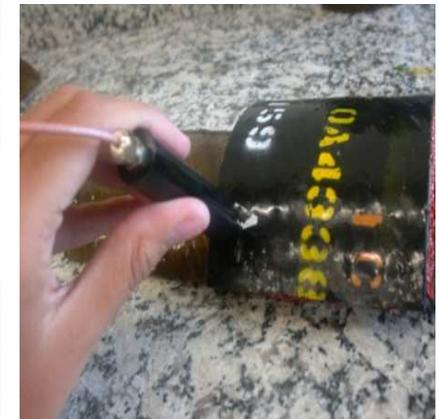
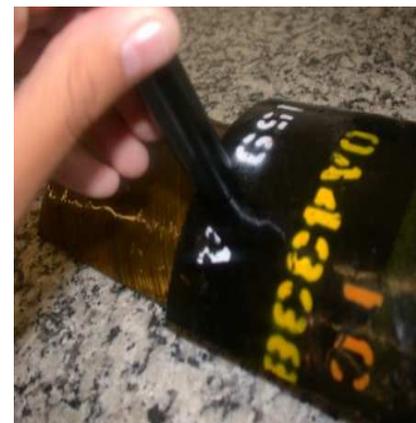
- Contact transducers:
  - 1.6MHz, 2.25MHz, 5MHz.
- Ultrasonic Equipment: GE USIP 40
- Manual Scanning

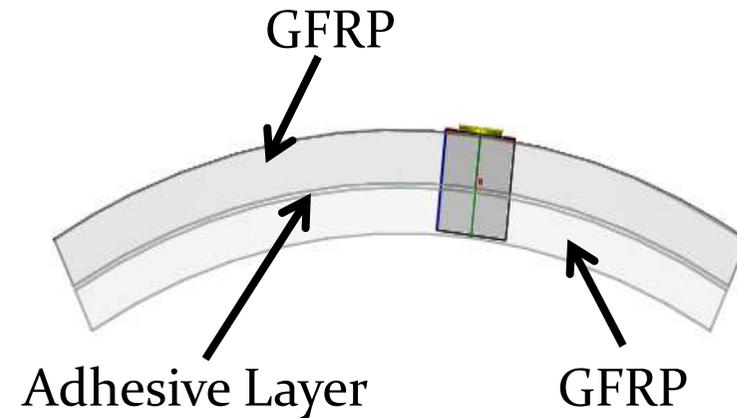
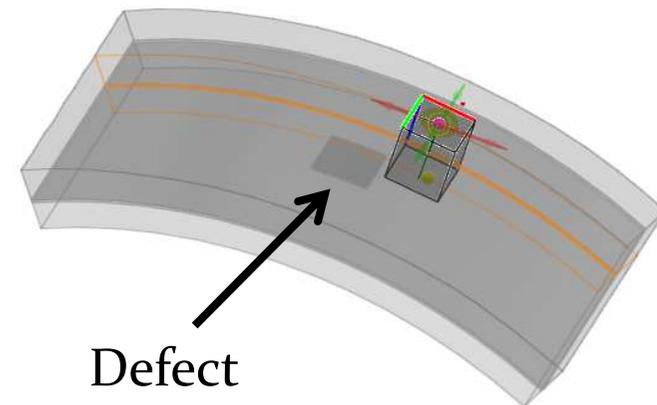
1.6 and 2.25MHz  
Transducers

Scanning step: 9mm

Computation of surface,  
interface and backwall  
echos

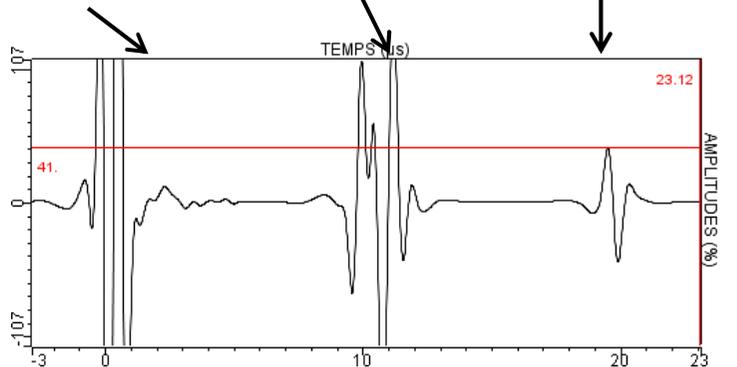
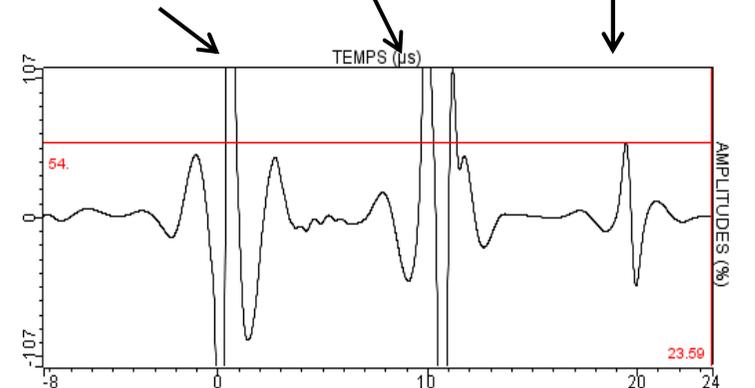
1.6MHz – Defective Area

2.25 MHz – Defective Area

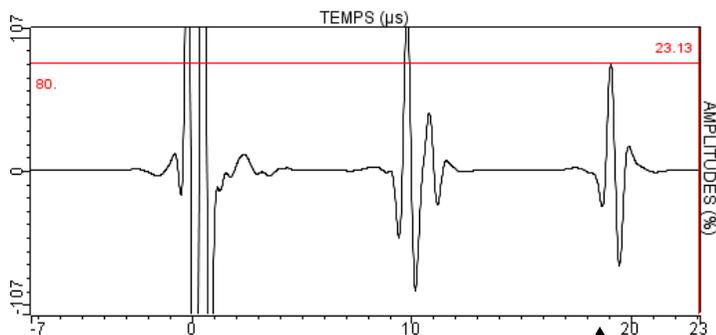
### 1.6 MHz – Non Defective Area

Surface      Adhesive      Backwall

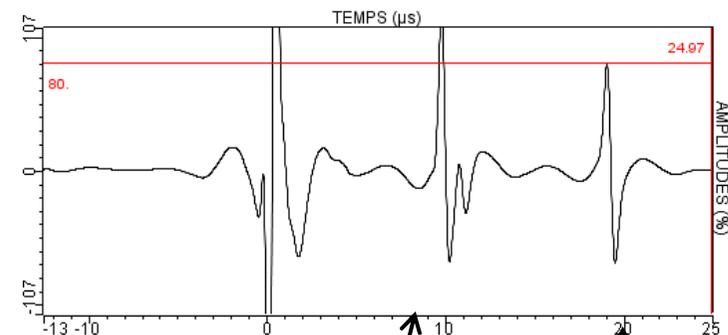
### 2.25 MHz – Non Defective Area

Surface      Adhesive      Backwall

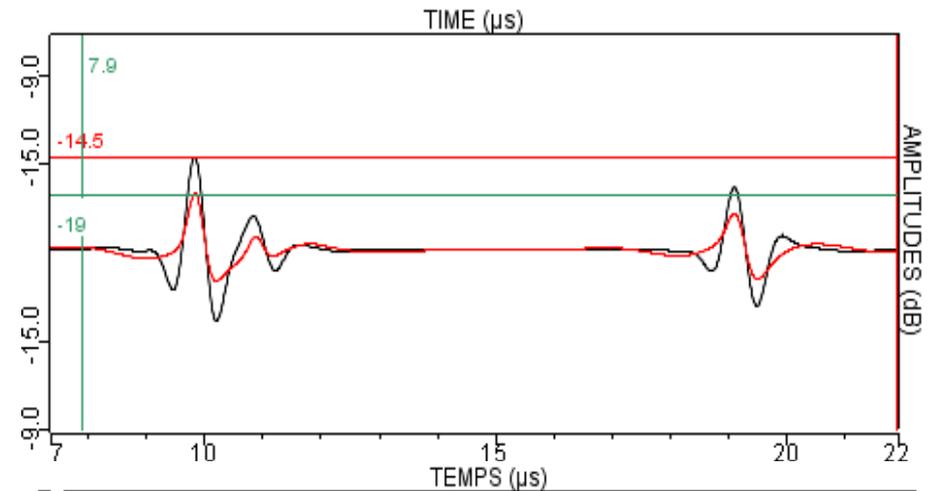
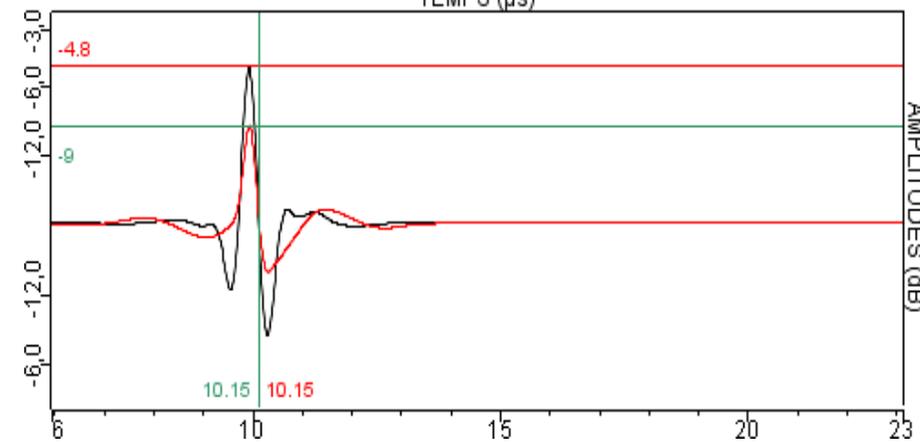
— 1.6MHz  
— 2.25MHz

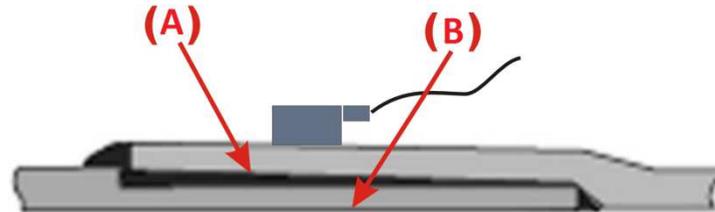
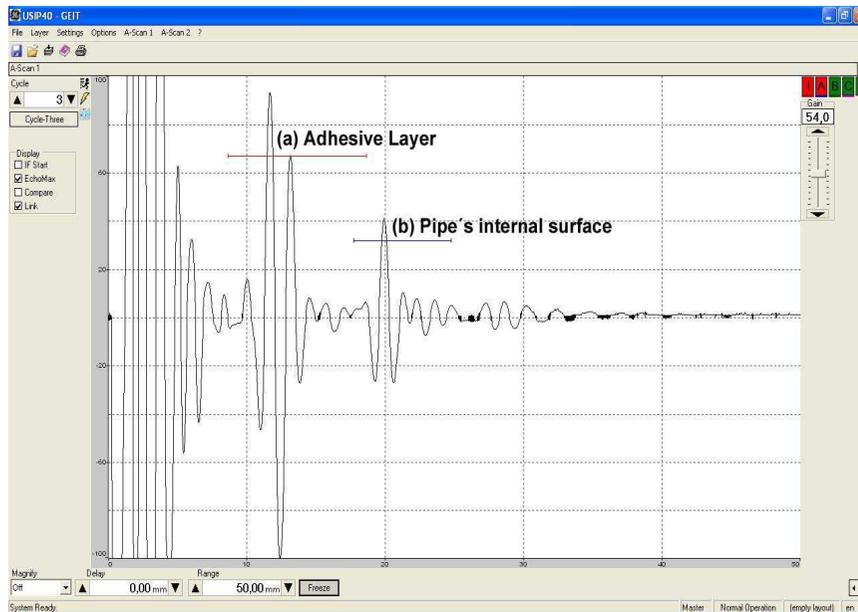
Non defective areas

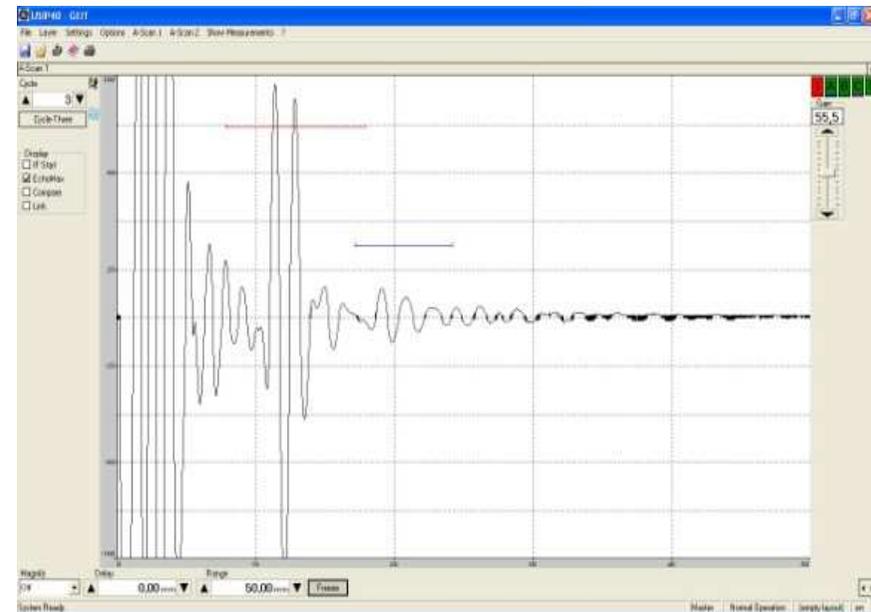
Defective areas

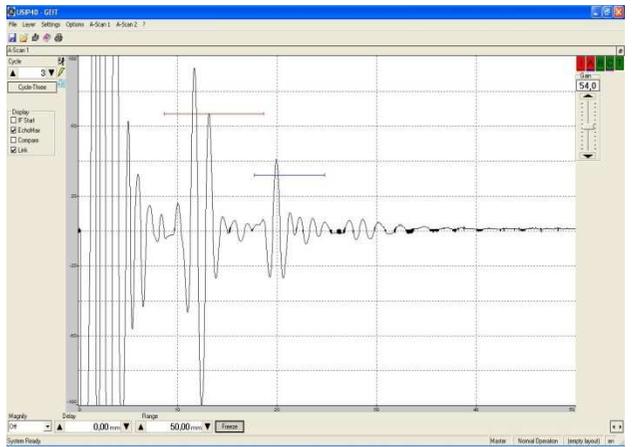
1 MHz

- Signals taken from the reference block
- 2.25MHz: the lowest frequency that returned good signals
- Used transducer: Imasonic IM 1626, 1.6MHz

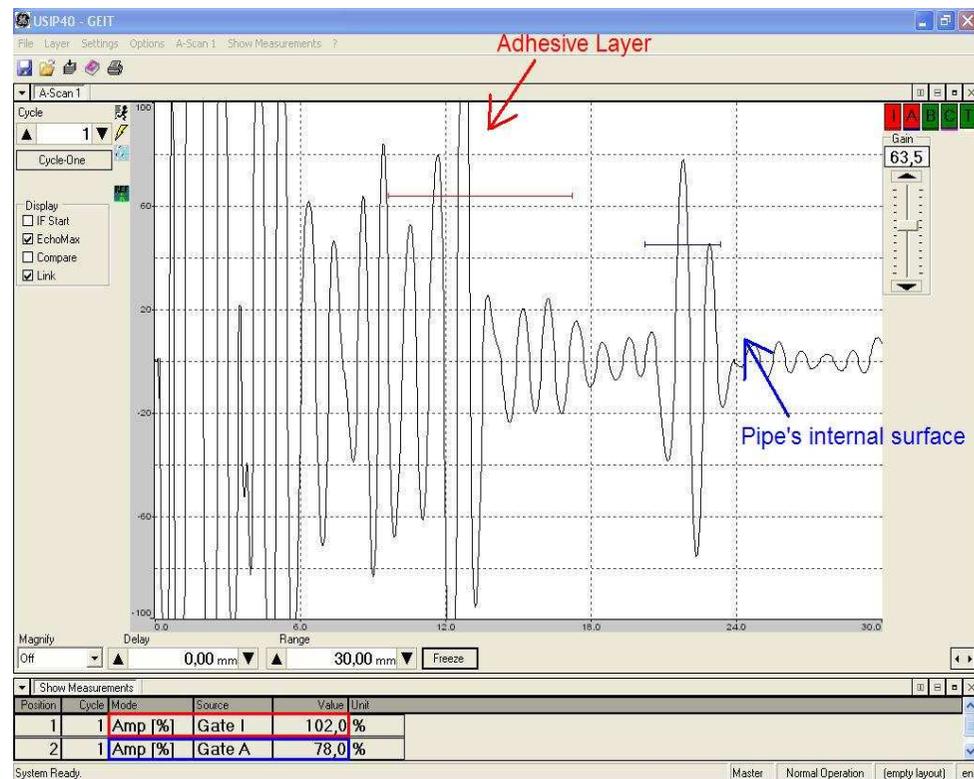
Take a signal from the reference block, adjust the gain to elevate the second signal (pipe's internal surface) to 80% of the display.

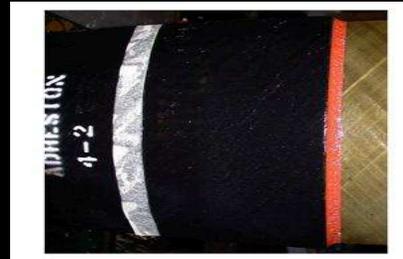
- Amplitudes below 35% - Defective Areas
- Amplitudes between 35% and 40% - Transition areas
- Amplitudes above 40% - Non-defective areas

Blue: well bonded areas  
 Yellow: Transition areas  
 Red: defective areas

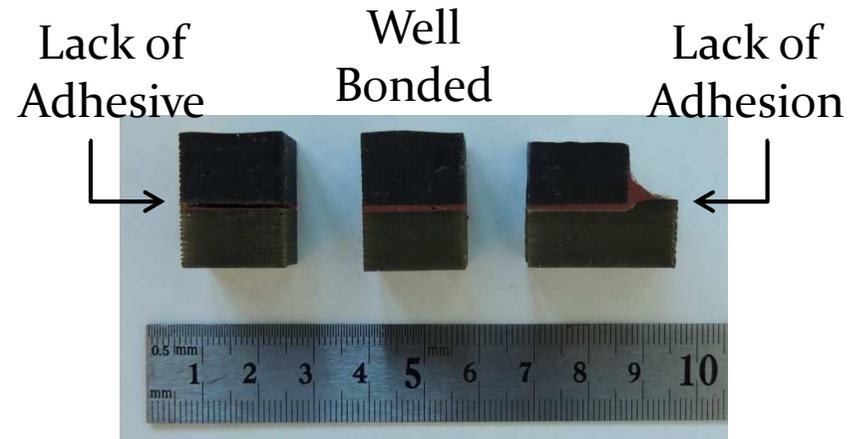
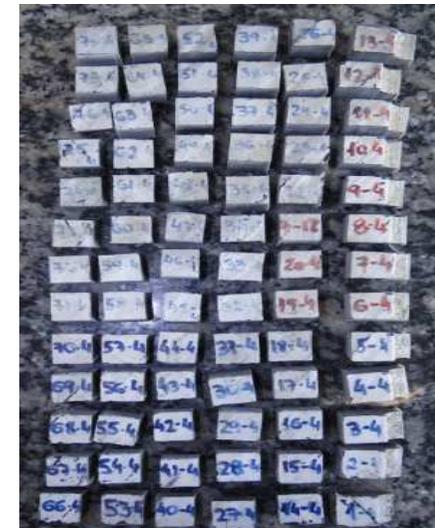
- Lack of Adhesion 4-2 and 4-3
- Lack of Adhesive 8-2 and 8-3

Method of evaluation:  
Visual inspection

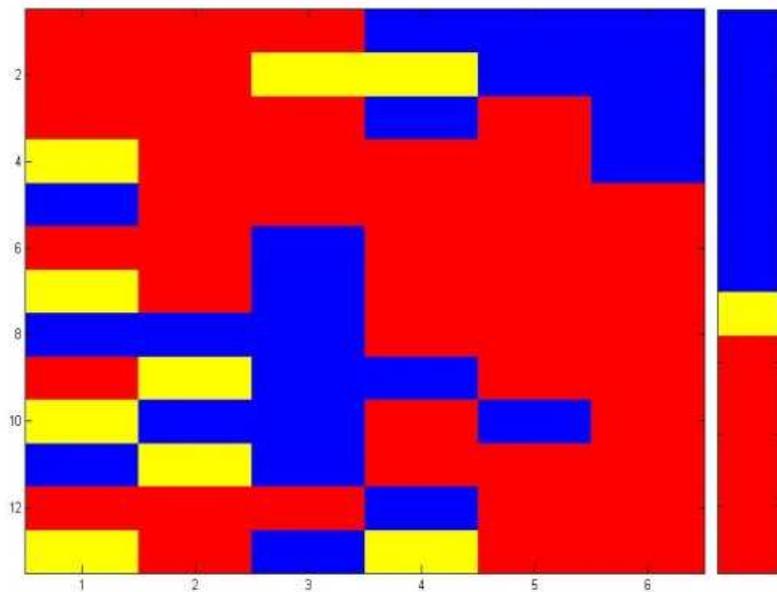
US C-scan

### Lack of Adhesive 8-2

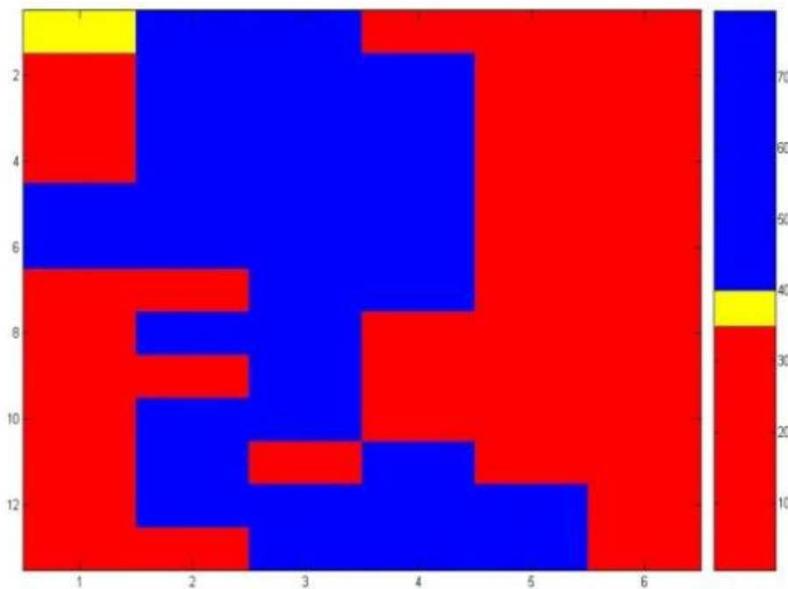
US C-scan

Lack of Adhesive 8-3

- Limitations of the proposed methodology:
  - Lack of Adhesion: US was not able to detect some areas with the presence of a foreign body (adhesive tape).
  - Lack of Adhesive: US was not able to precisely dimension some defective areas. Defective areas not entirely covered by the US beam can be mistaken for non-defective areas.

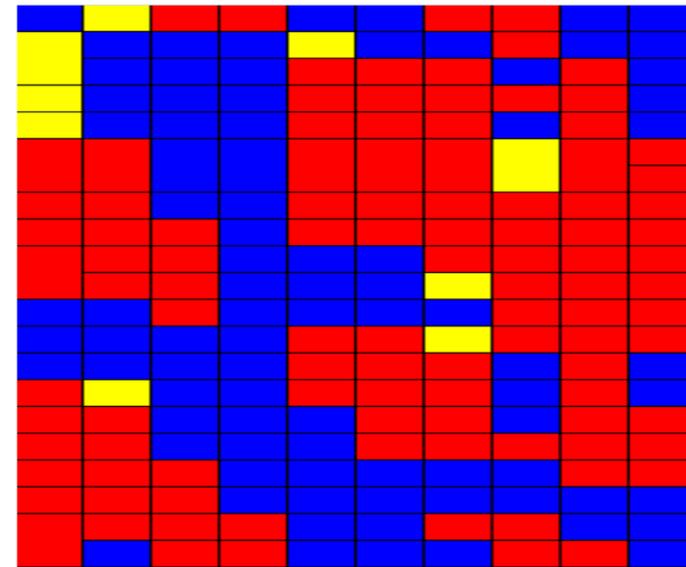
Real Map

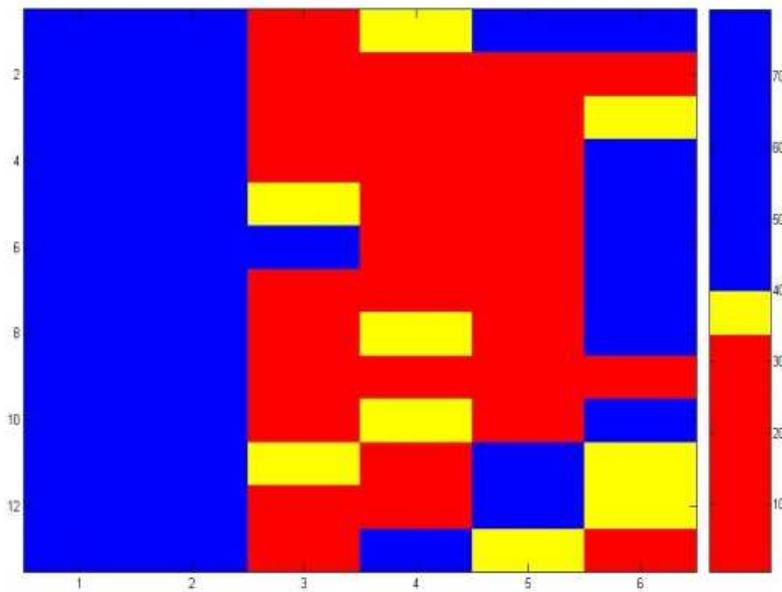
### Lack of Adhesion 4-2

US C-scan

Sample	Accuracy (%)
Lack of Adhesion 4-2	70
Lack of Adhesion 4-3	74
Lack of Adhesive 8-2	69
Lack of Adhesive 8-3	65

Accuracy: based on the comparison between C-scan and real maps.

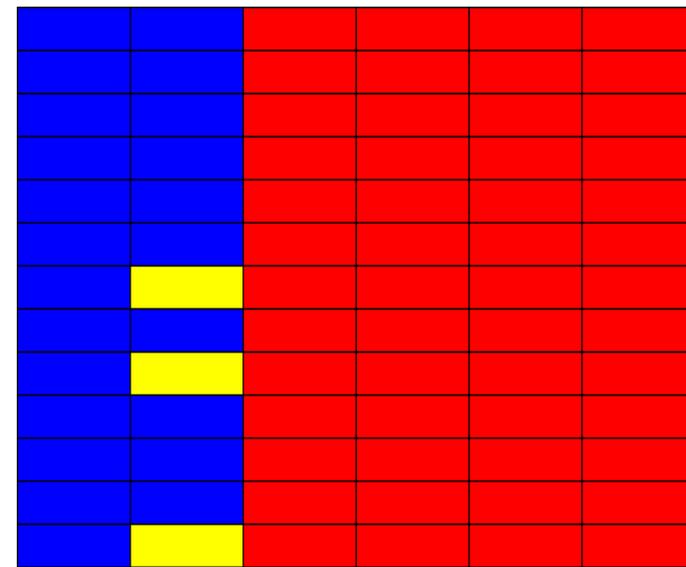
Real Map

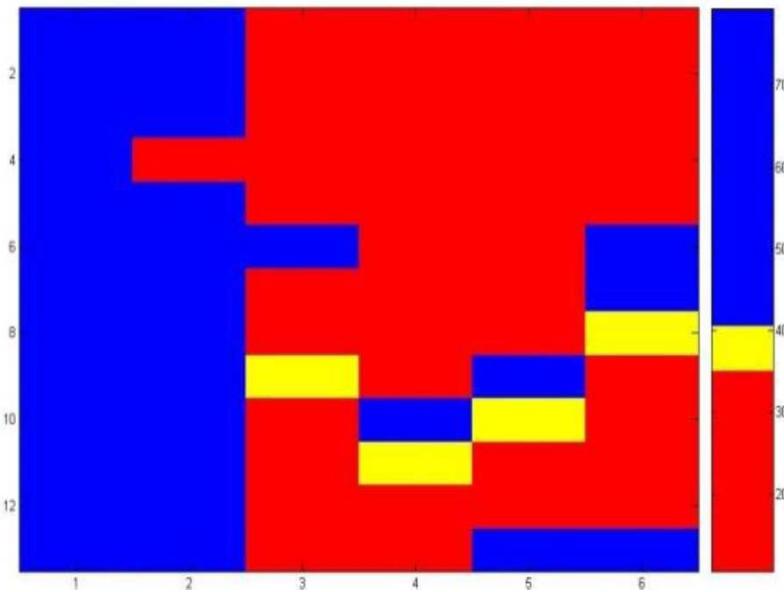
### Lack of Adhesion 4-3

US C-scan

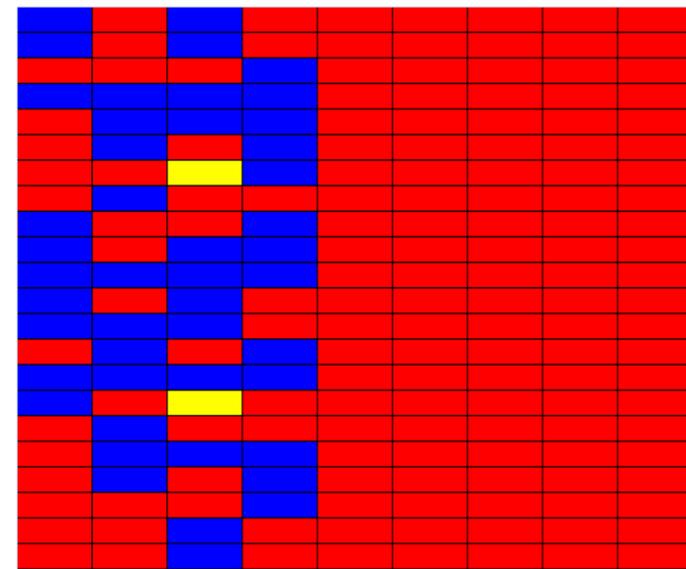
Real Map

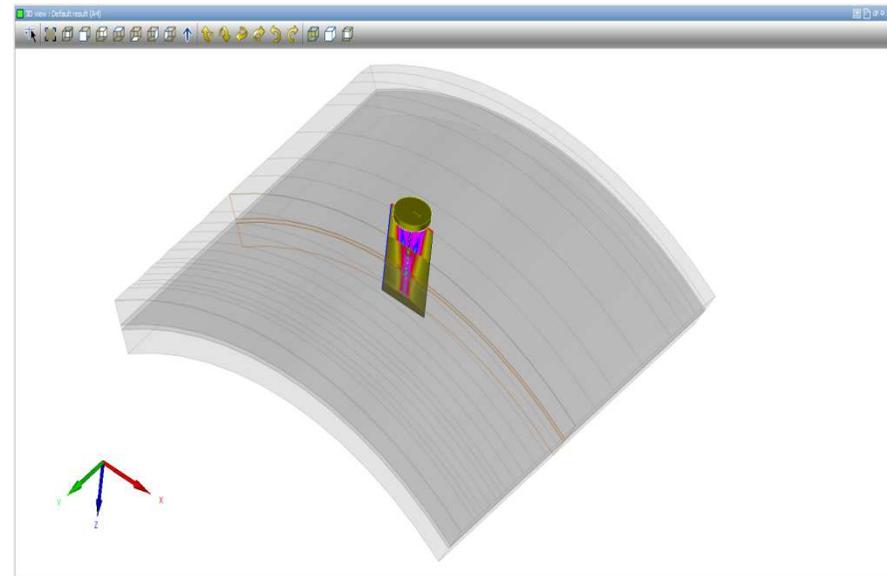
- Focused Transducers: concentration of the energy at a focal spot
- CIVA simulation of a 1MHz commercially available transducer

Focused transducers may improve sensibility and resolution

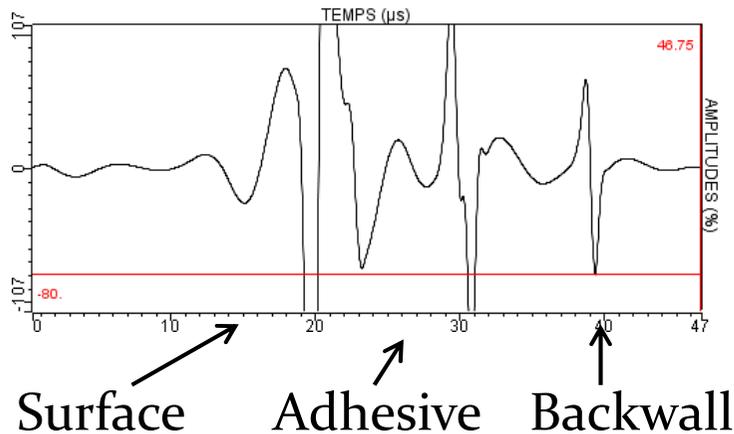
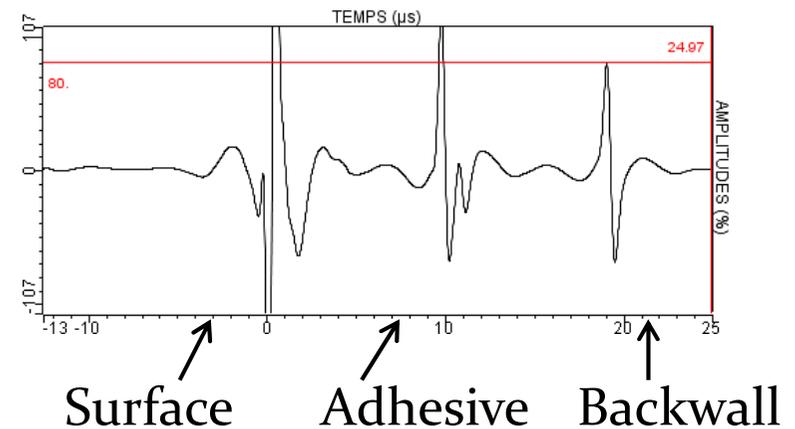
Well Bonded

## Focused Transducer Simulations

### Lack of Adhesion

### Lack of Adhesive
